March's Point Geomorphic Assessment & Drift Cell Restoration Prioritization

Prepared for:
Skagit County Marine Resources Committee

Prepared by:
Coastal Geologic Services Inc.
Jim Johannessen, LEG, MS and
Andrea MacLennan, MS

March 6, 2007

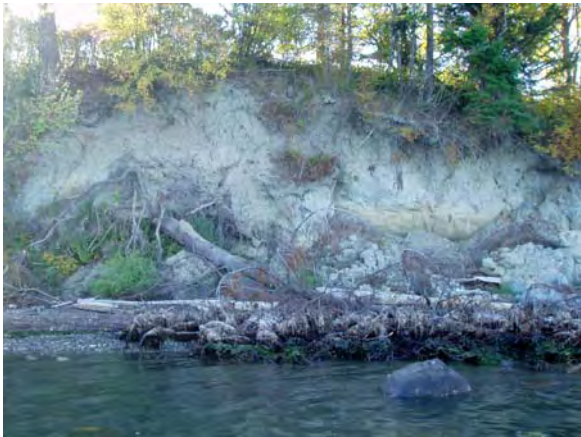
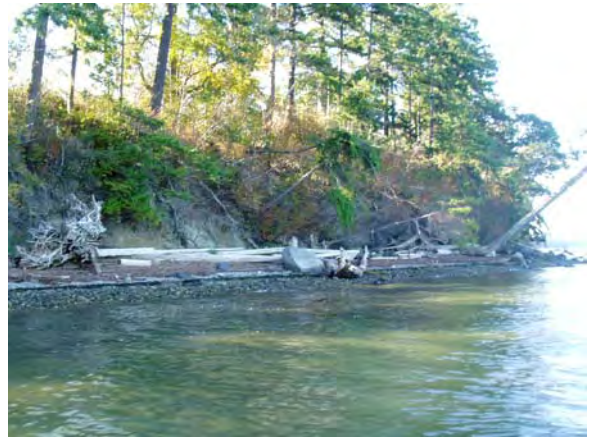
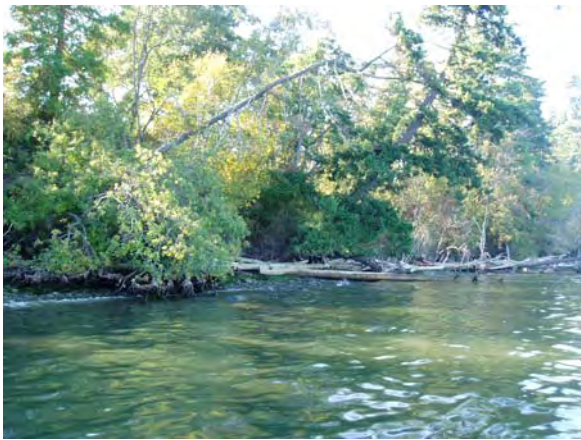
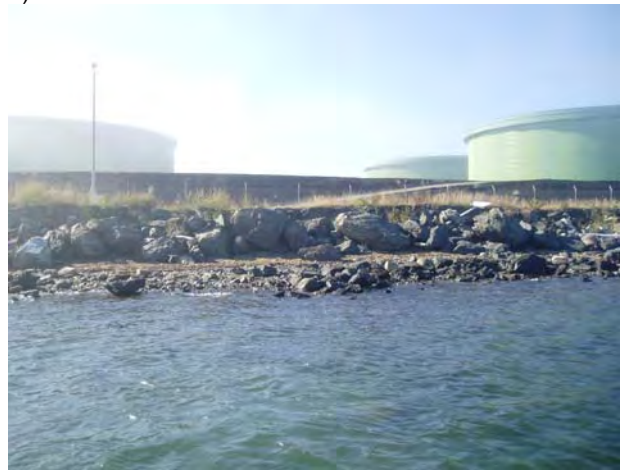
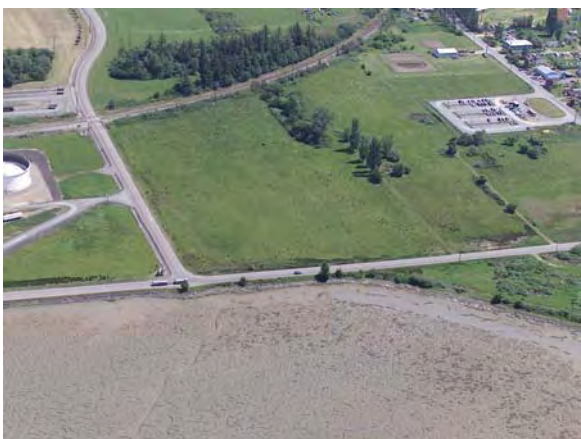
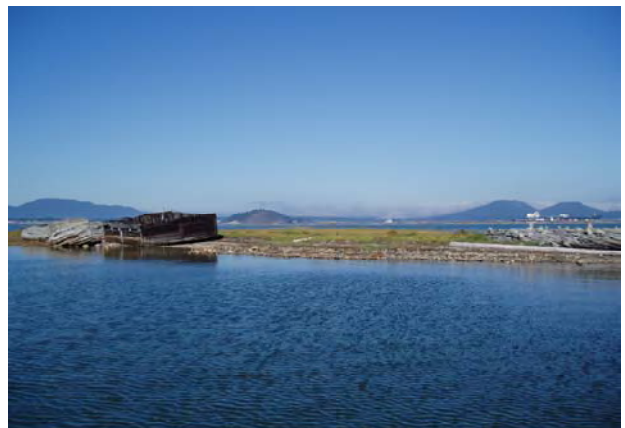
a) Feeder bluff

b) Feeder bluff

c) Transport zone

d) Modified

e) No appreciable drift

f) Accretion shoreform

Figure 2. Photos of representative geomorphic shoretypes for the March's Point area. (a-d, f CGS field photos, e WDOE aerial oblique photo).

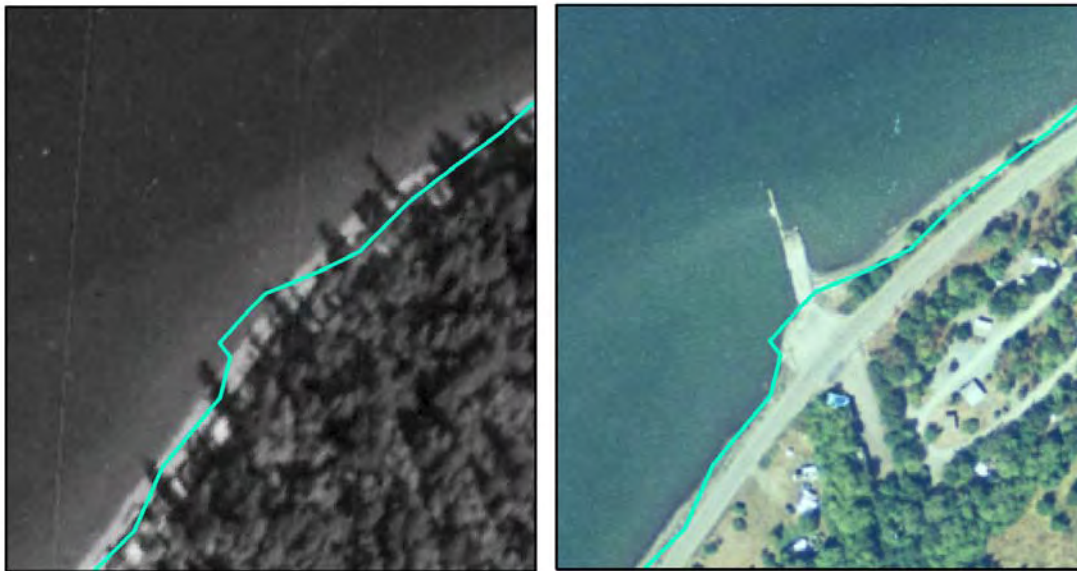
Figures 14 and 15. Boat ramp area in cell SK-E-4 showing accumulated sediment on up-drift side of the ramp and eroded beach on the down-drift side, indicating the boat ramp is obstructing littoral sediment transport. Photos courtesy of United States Army Corps of Engineers, 1943 and Washington State Department of Natural Resources, 2003. Scale 1:3,500.

A process-based restoration action along the north shore of March's Point (in cell SK-E-4) that will benefit Crandall Spit is to reconfigure the large boat ramp (located between the refinery docks) so that it no longer impedes longshore sediment transport. Currently, the ramp is a large concrete structure that extends approximately 175 ft from the bank, and acts as a groin, blocking littoral transport across the entire beach profile. In addition, the long-term stability of the ramp is a bit questionable with an eroding beach on the west side and the apparent lack of careful design and construction.

The interruption of net shore-drift caused by the boat ramp is evident by the considerable accumulation of sediment on the eastern, up-drift shore. The western, or down-drift shore, appears to be substantially deprived of sediment, with little to no remaining upper beach habitat (Figures 14 and 15). Reconfiguring the boat ramp to restore coastal processes could be conducted by building the ramp on poured concrete or metal pilings, rather than as a solid structure. This alternative design would also restore the lost intertidal habitat currently buried by the concrete ramp. The new boat ramp could be built adjacent to the current ramp, assuring the presence of a fully functional boat ramp (in the event of an emergency) through the construction period. After construction of the new ramp was completed, the old ramp could be deconstructed and removed from the nearshore.

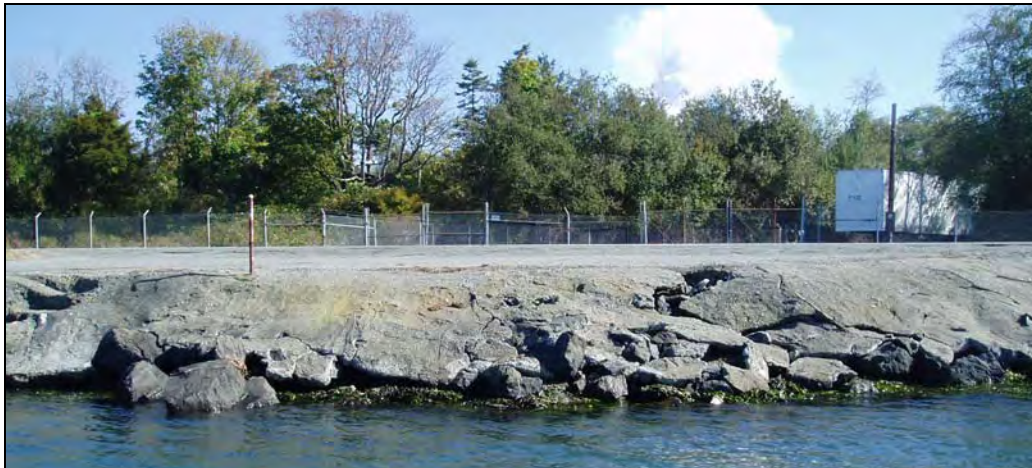
Figure 17. Lack of an upper beach and armoring immediately down-drift (southeast) of the large concrete boat ramp in cell SK-E-4. (CGS field photo)

The shore just southwest of the large concrete boat ramp northeast of Crandall Spit also scored high in the nourishment prioritization model (Figure 16). This is the same reach selected by Dan Penttila (2000/2001) in a proposal to the Texaco Restoration Fund using an empirical, field-based approach for project selection. That proposal called for beach nourishment of 2,400 cubic yards (cy) of "sand-gravel material" spread between elevation +5 to +9 ft MLLW. Beach nourishment could provide considerable benefit to the impacted nearshore habitats down-drift of the boat ramp, where the beach is very degraded (Figure 17). This area is recommended as the second highest priority for nourishment in the current study, as it has almost as high as the highest scoring drift cell (discussed below as the highest recommended nourishment area), was highly degraded in term of beach sediment, and is also up-drift of Crandall Spit. The sediment would be gradually transported to the spit over time, helping to "bolster" the eroding north arm of the spit. One outstanding issue is the private boat ramp located a short distance northeast of the Shell pier base. Additional nourishment should be placed southeast of the north tide channel at Crandall Spit to mitigate erosion in that area, as discussed in the above section.

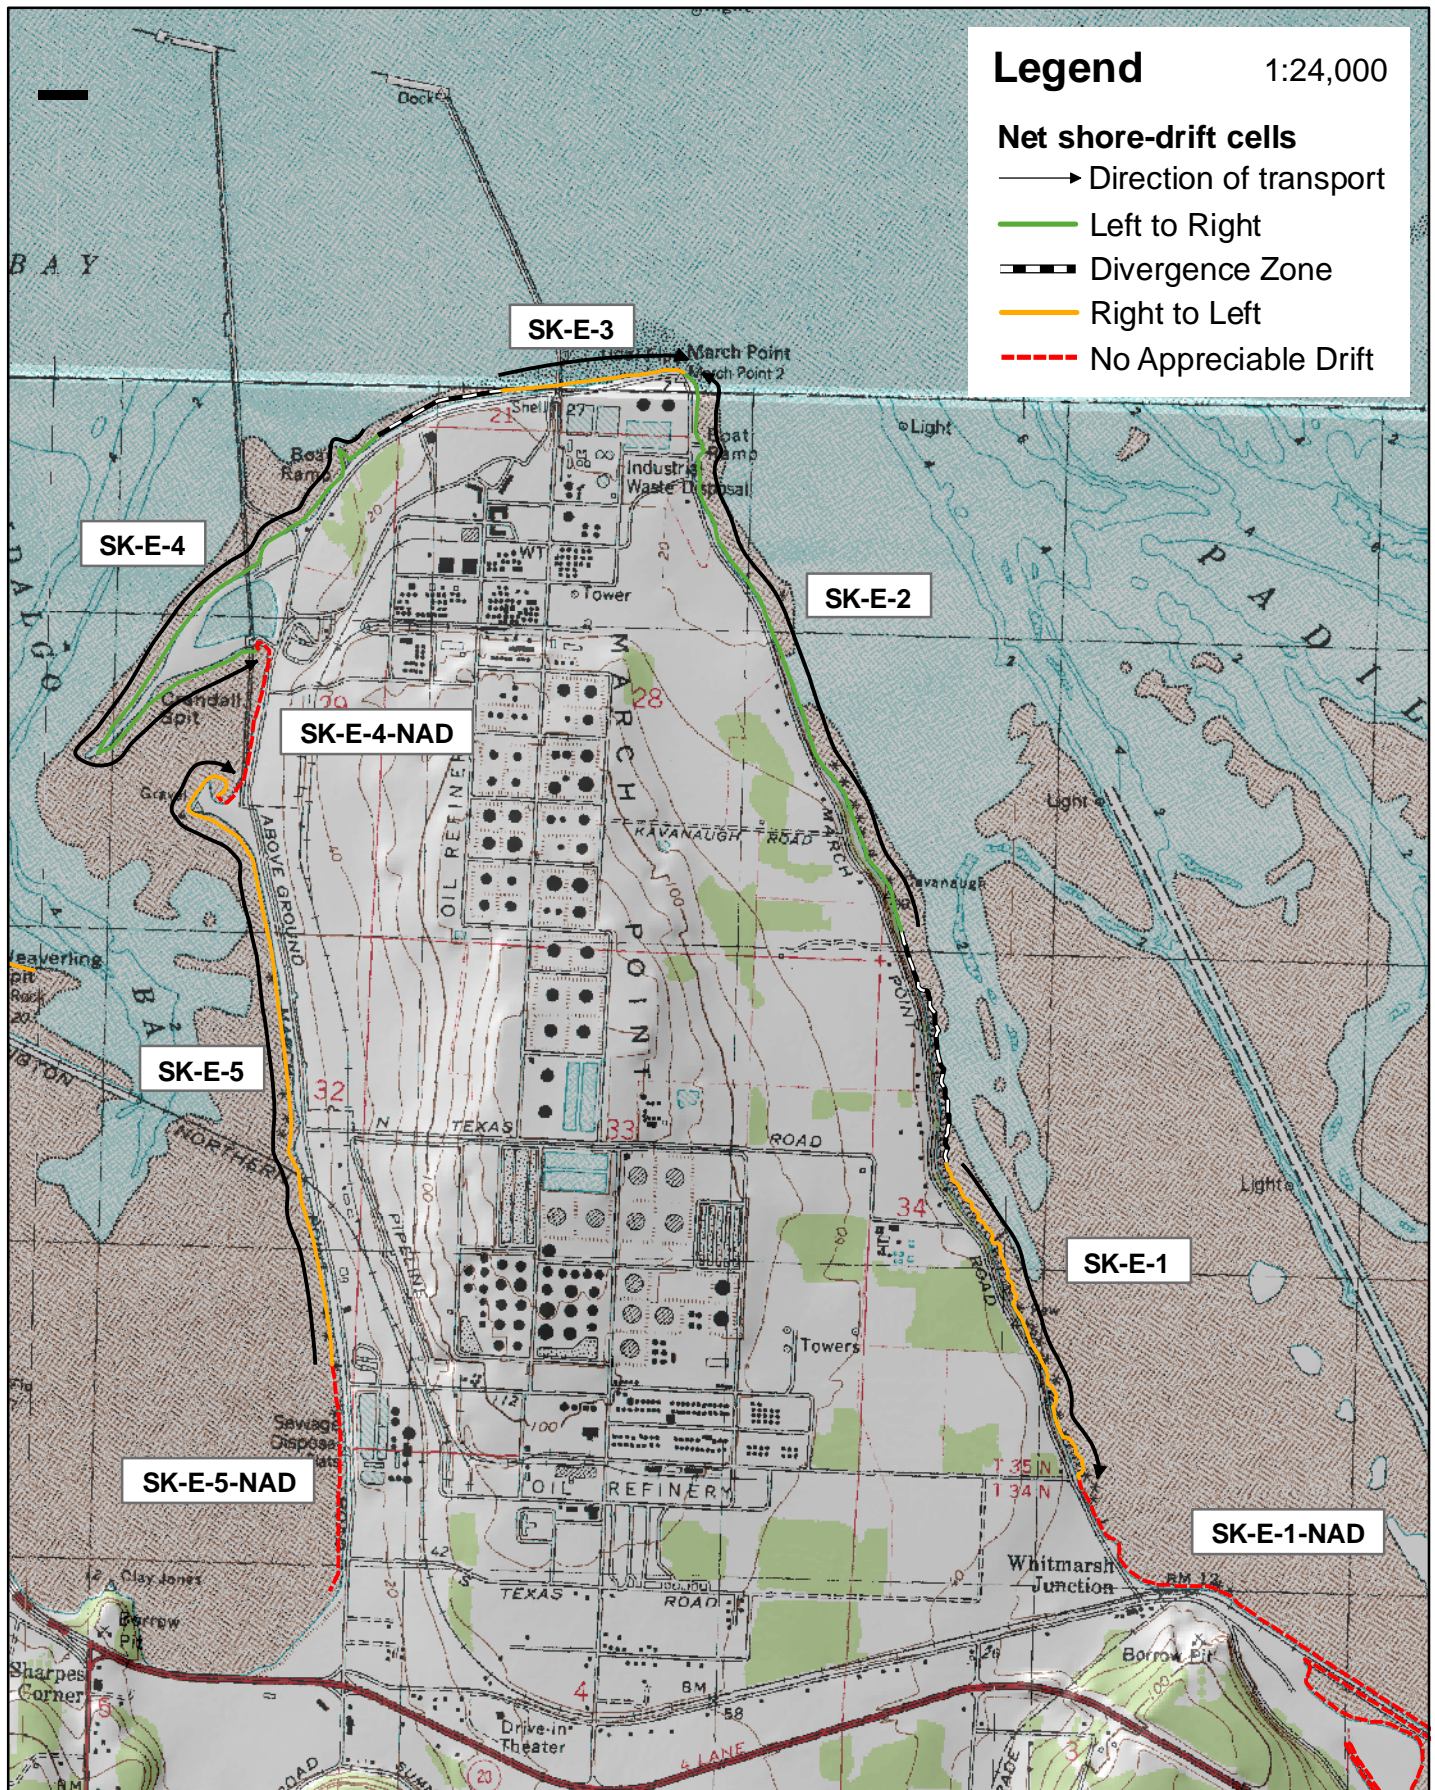
Figure 1. Net shore-drift around March's Point.

Based on Washington State Dept of Ecology (2001) online dataset and Keuler (1979) and modified by Coastal Geologic Services, Inc. 2006. Digital elevation model and topographic map (USGS).

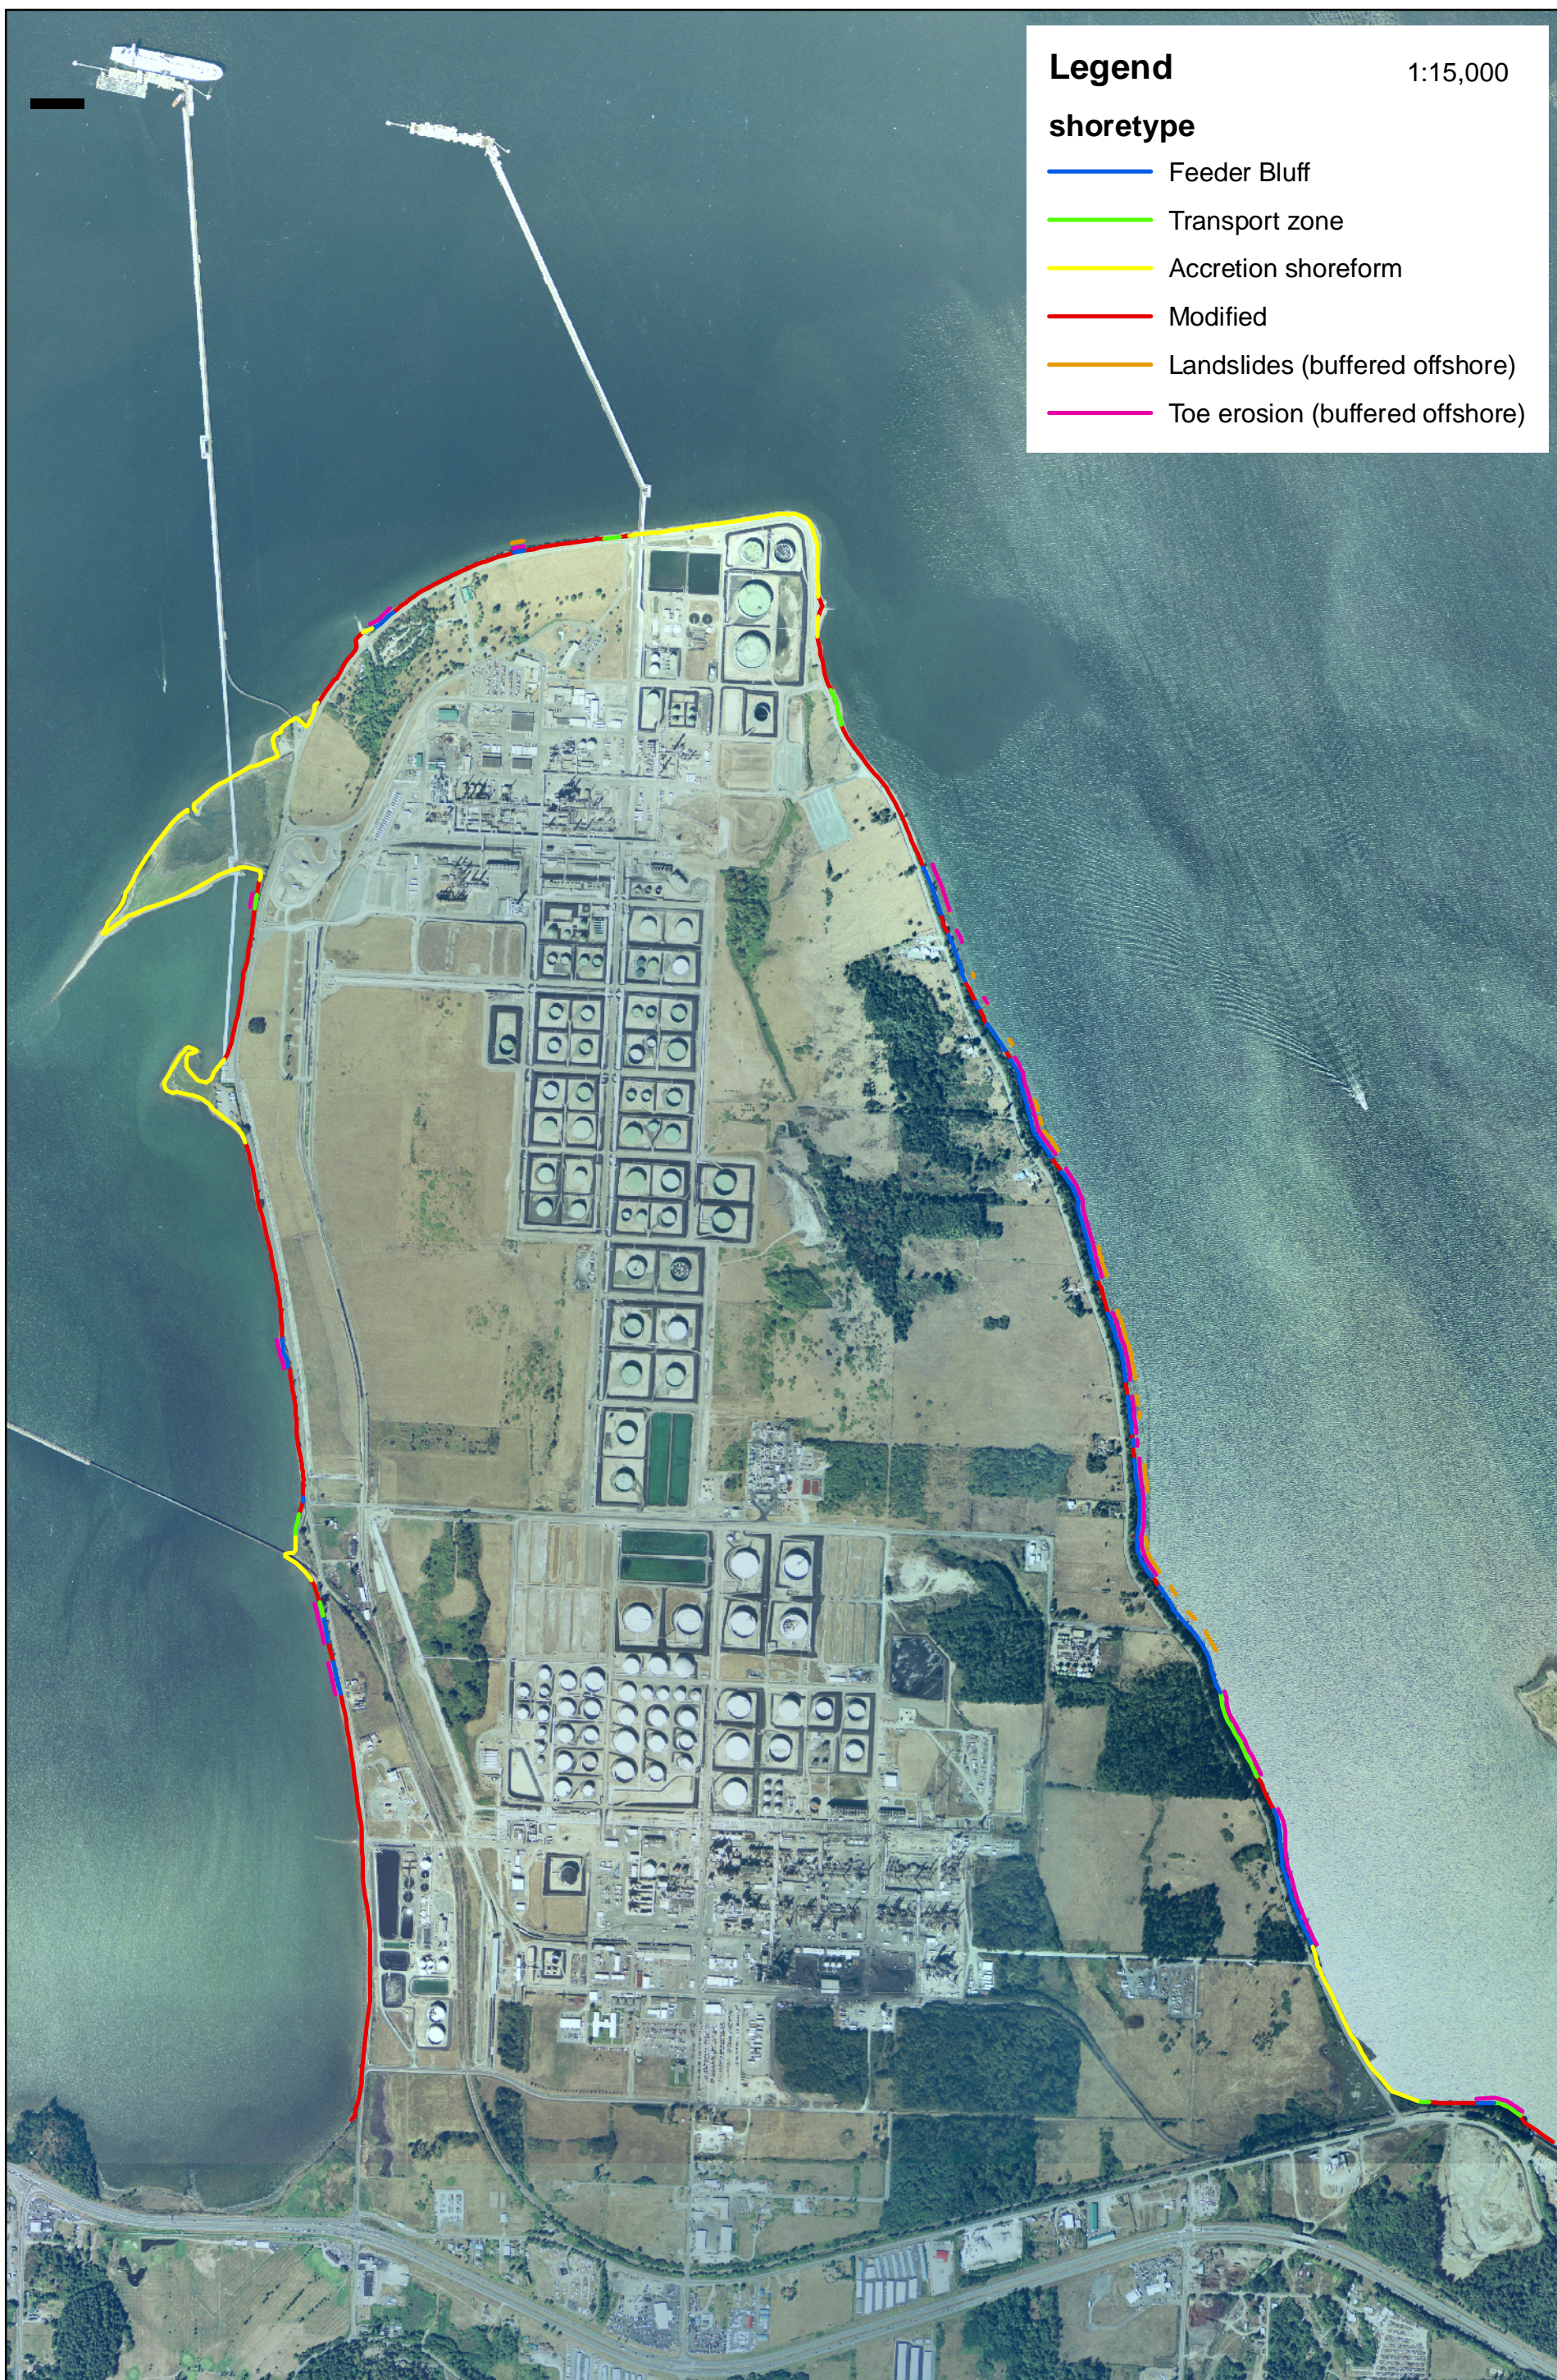
**Figure 4. Current geomorphic conditions of March's Point shores.
Toe erosion and Landslides buffered offshore.**

The shoretypes that make up each drift cell varied considerably across the study area. Sediment sources or feeder bluffs were most abundant along the eastern and northern shores, while accretion shoreforms were more frequently mapped along the northwest and west shores. Landslides and toe erosion were also more abundant along the east and north shores, with some scattered toe erosion along the west shore. Detailed results of current conditions geomorphic mapping can be found in Tables 8 and Figure 4.

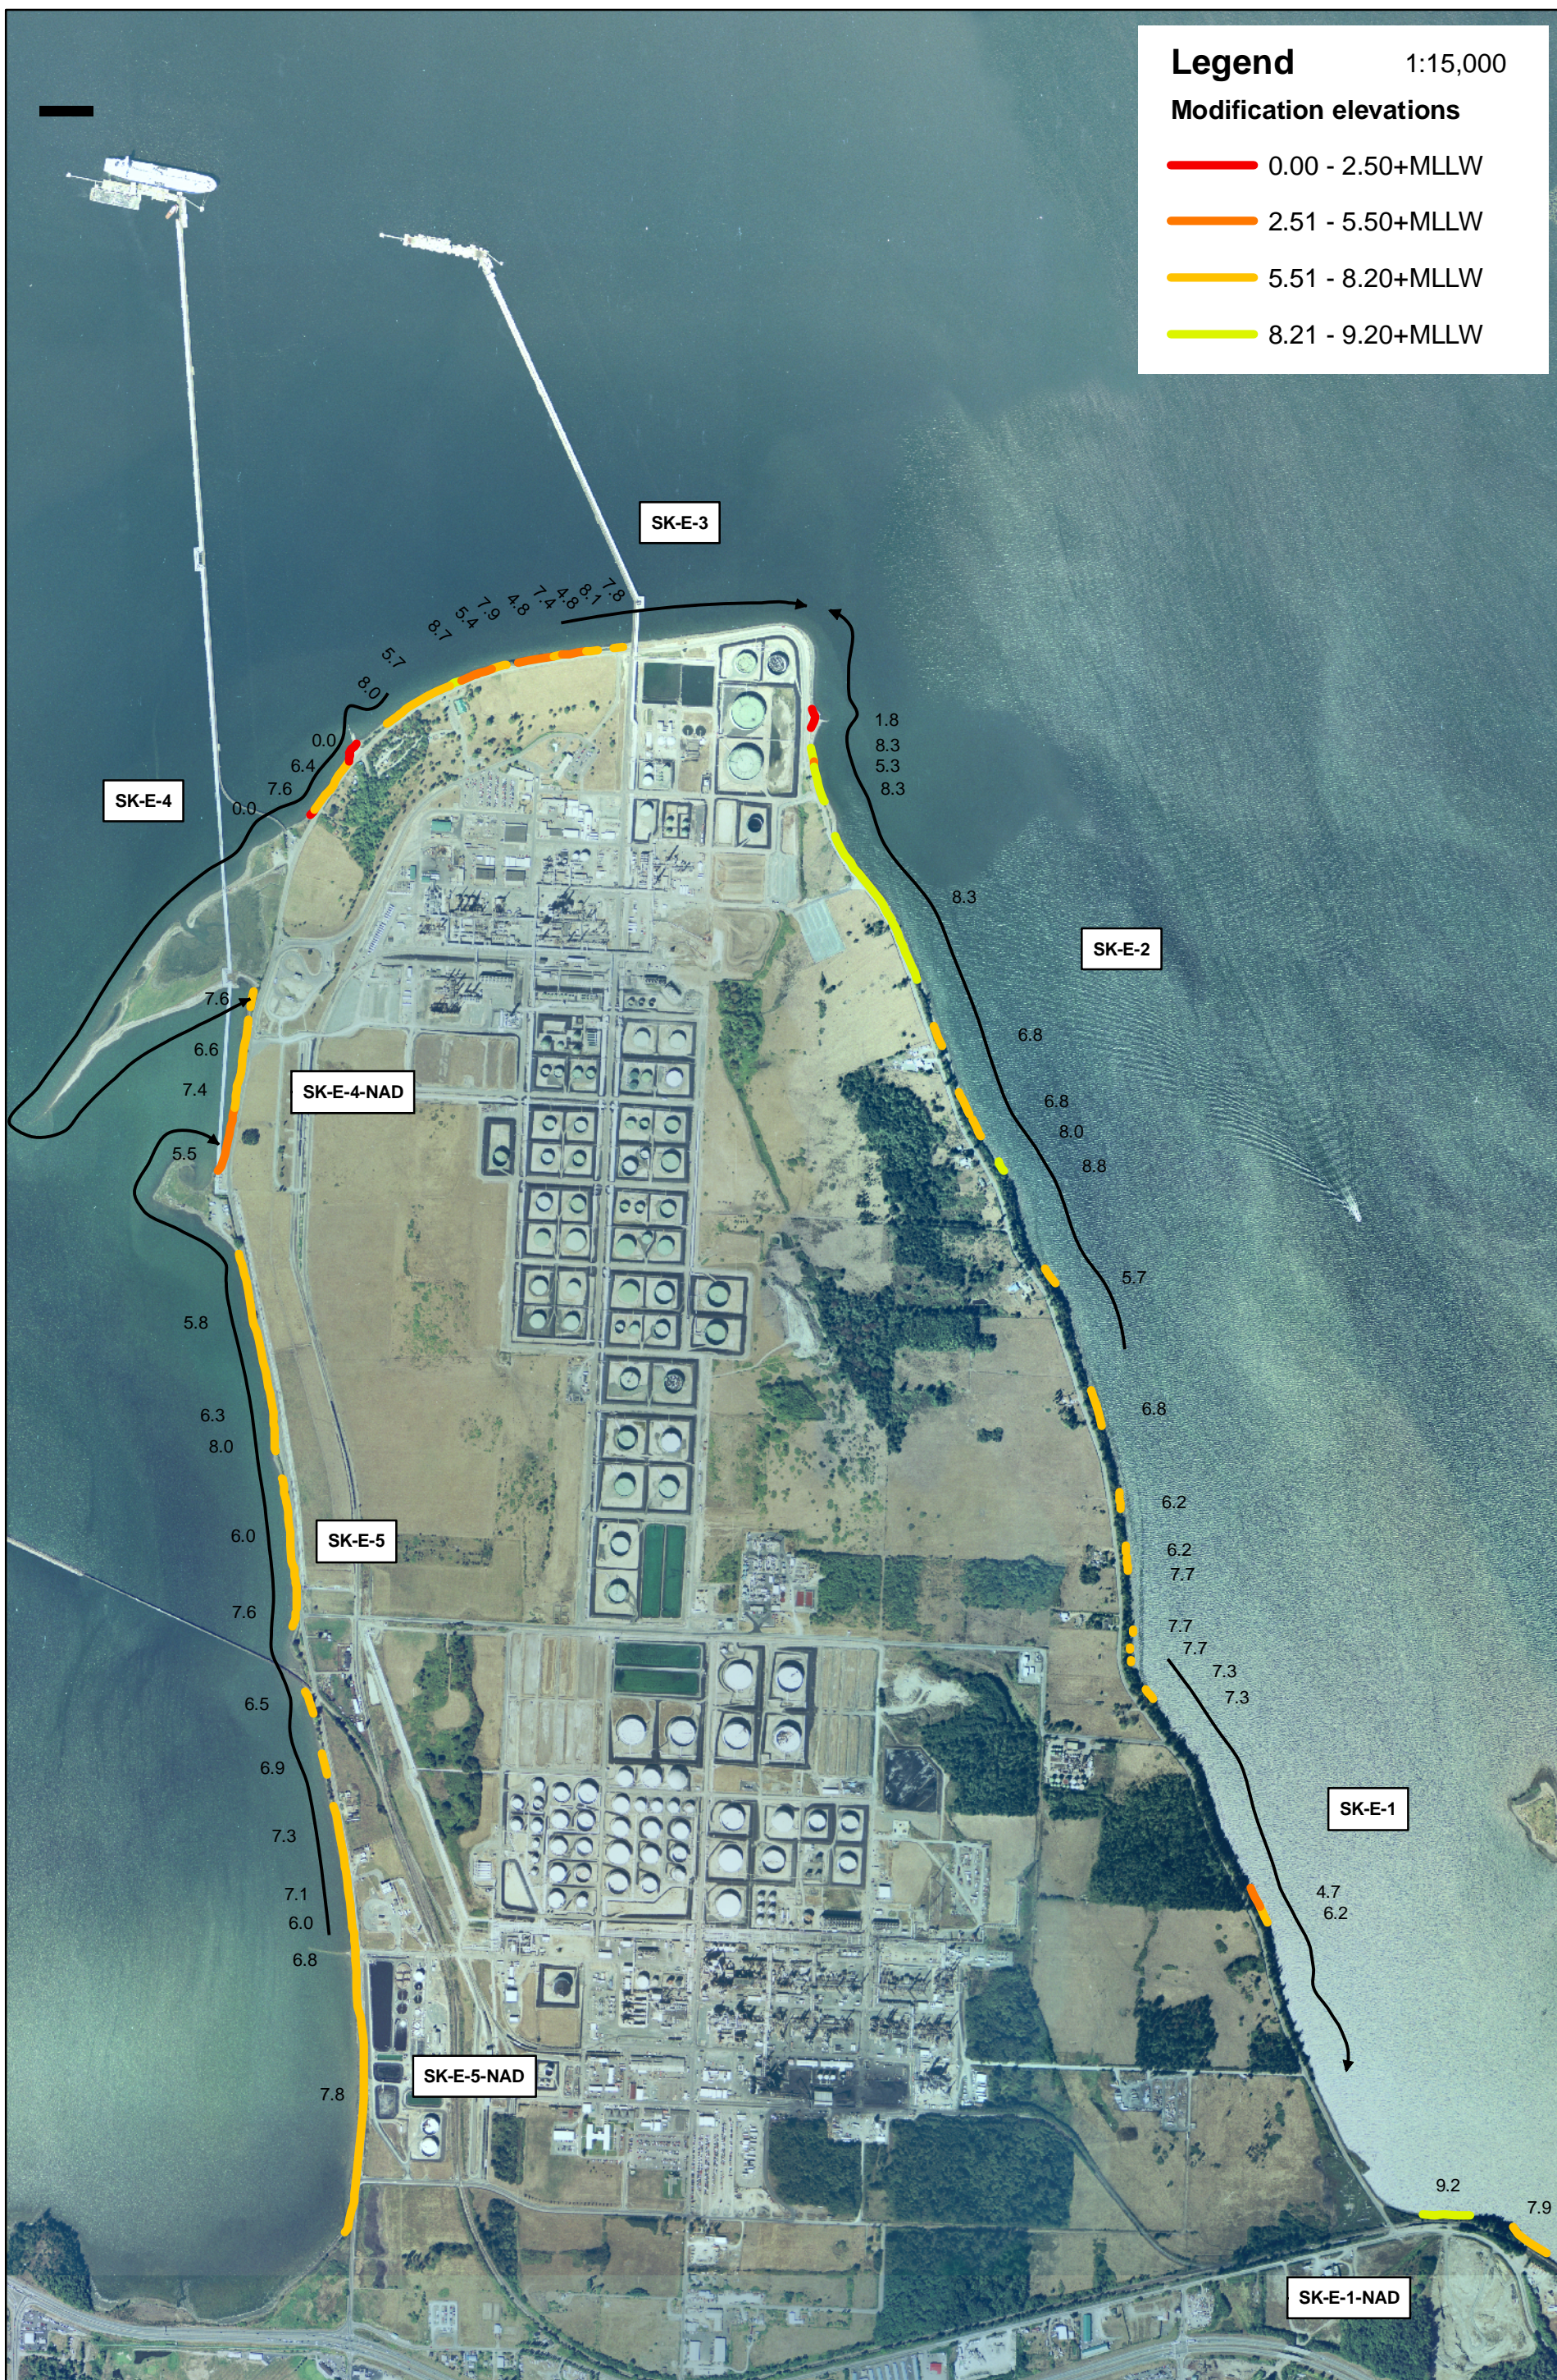
Figure 5. Elevation of all shore modifications along the March's Point shores

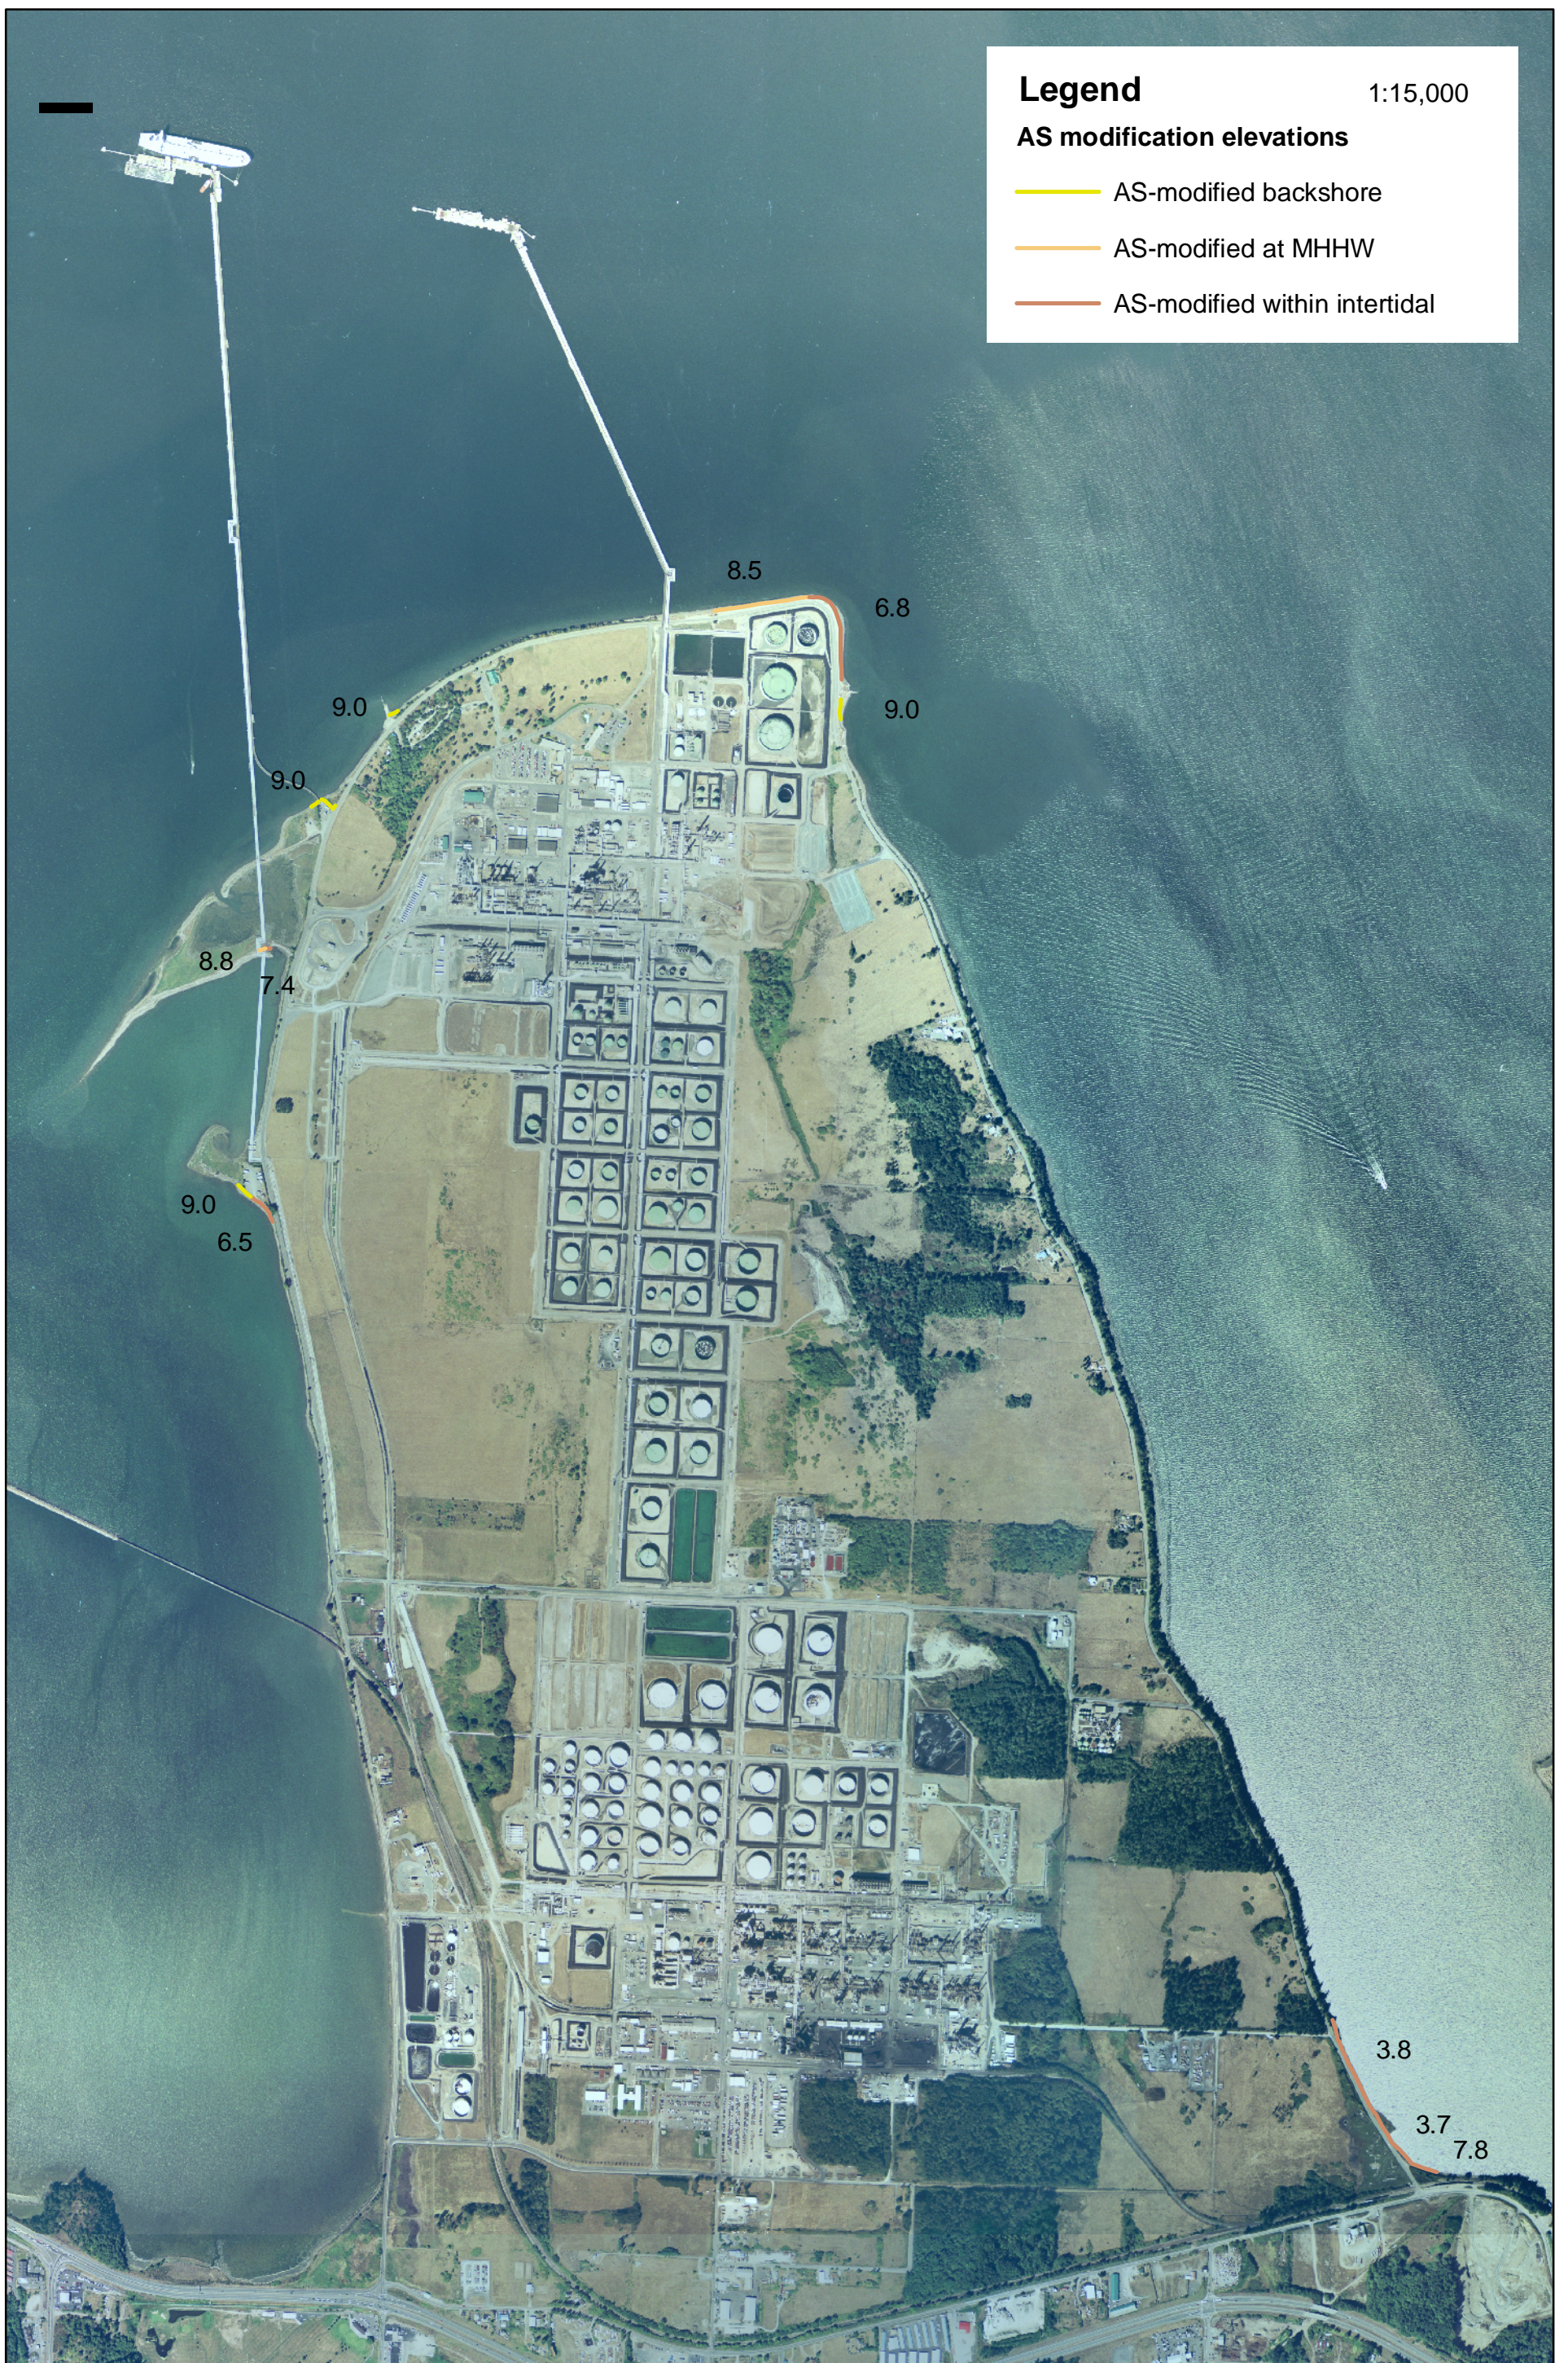
Figure 6. Elevation of all modified Accretion Shoreforms along the March's Point shores. All elevations + MLLW.

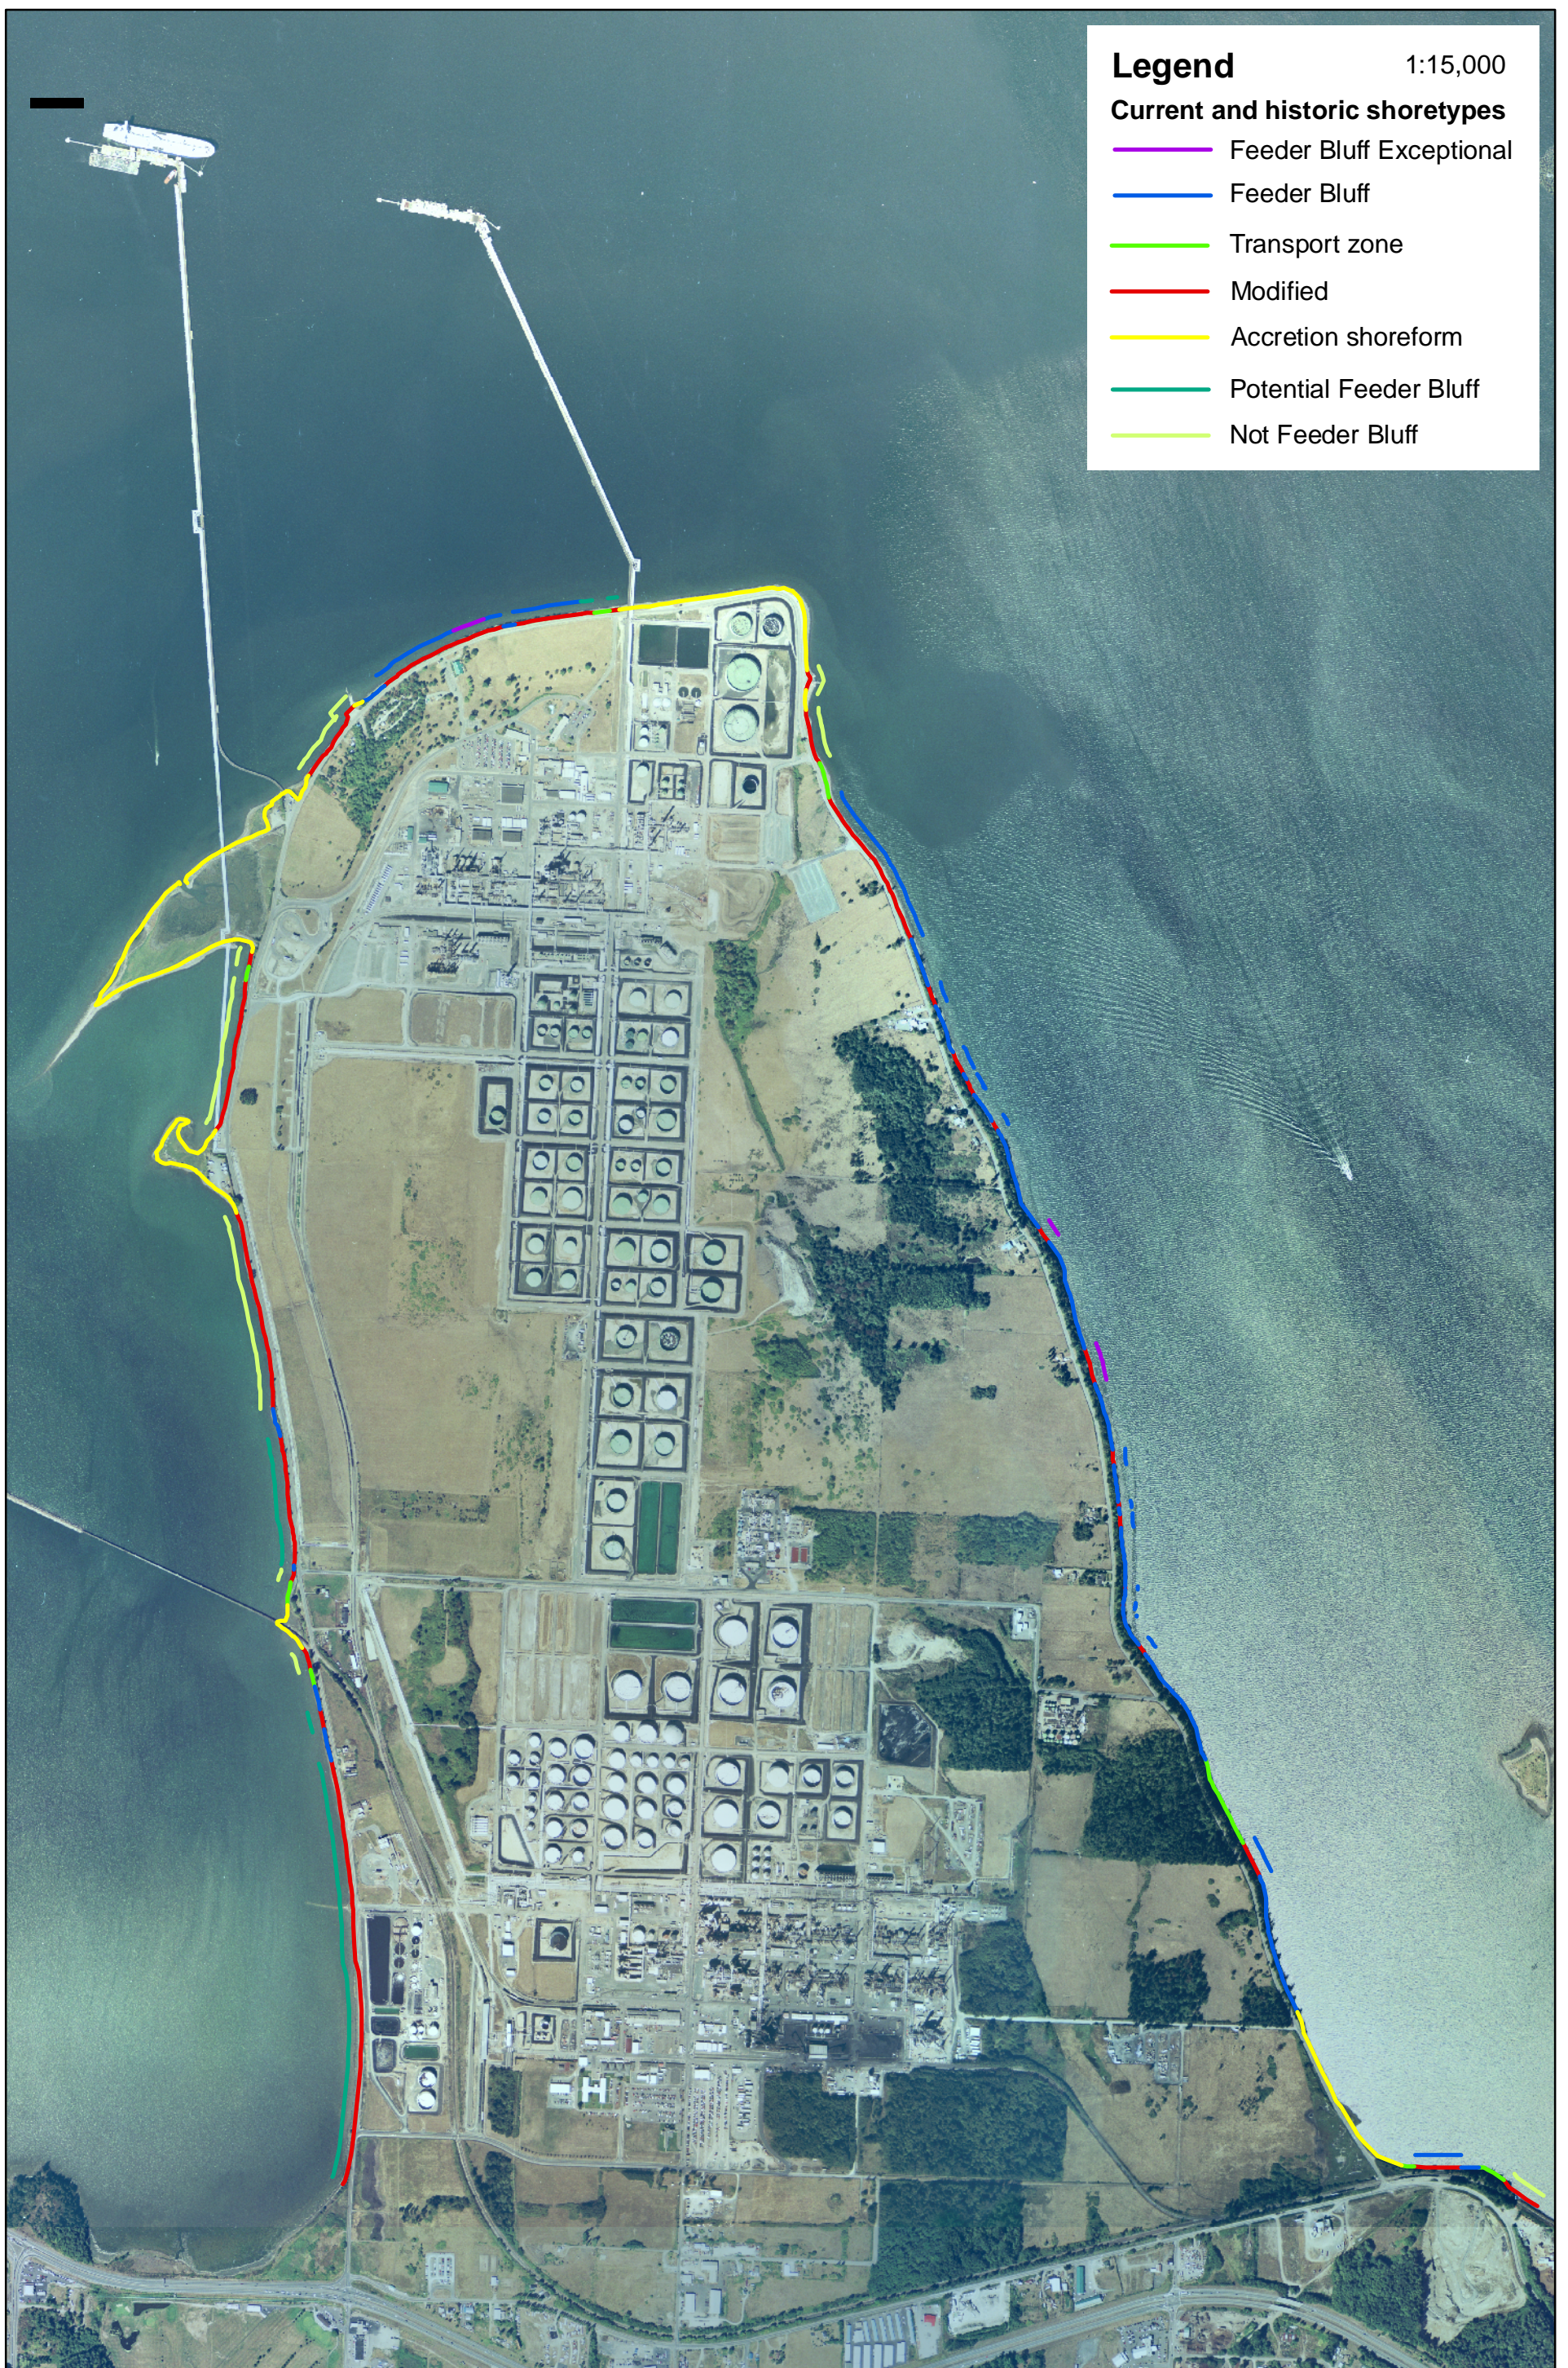
Figure 7. Current and Historic geomorphic conditions of March's Point shores. Historic conditions buffered offshore.

displays both current and historic conditions mapping with historic shoretypes displayed buffered offshore.
