March's Point Geomorphic Assessment & Drift Cell Restoration Prioritization

Prepared for:
Skagit County Marine Resources Committee

Prepared by:
Coastal Geologic Services Inc.
Jim Johannessen, LEG, MS and
Andrea MacLennan, MS

March 6, 2007

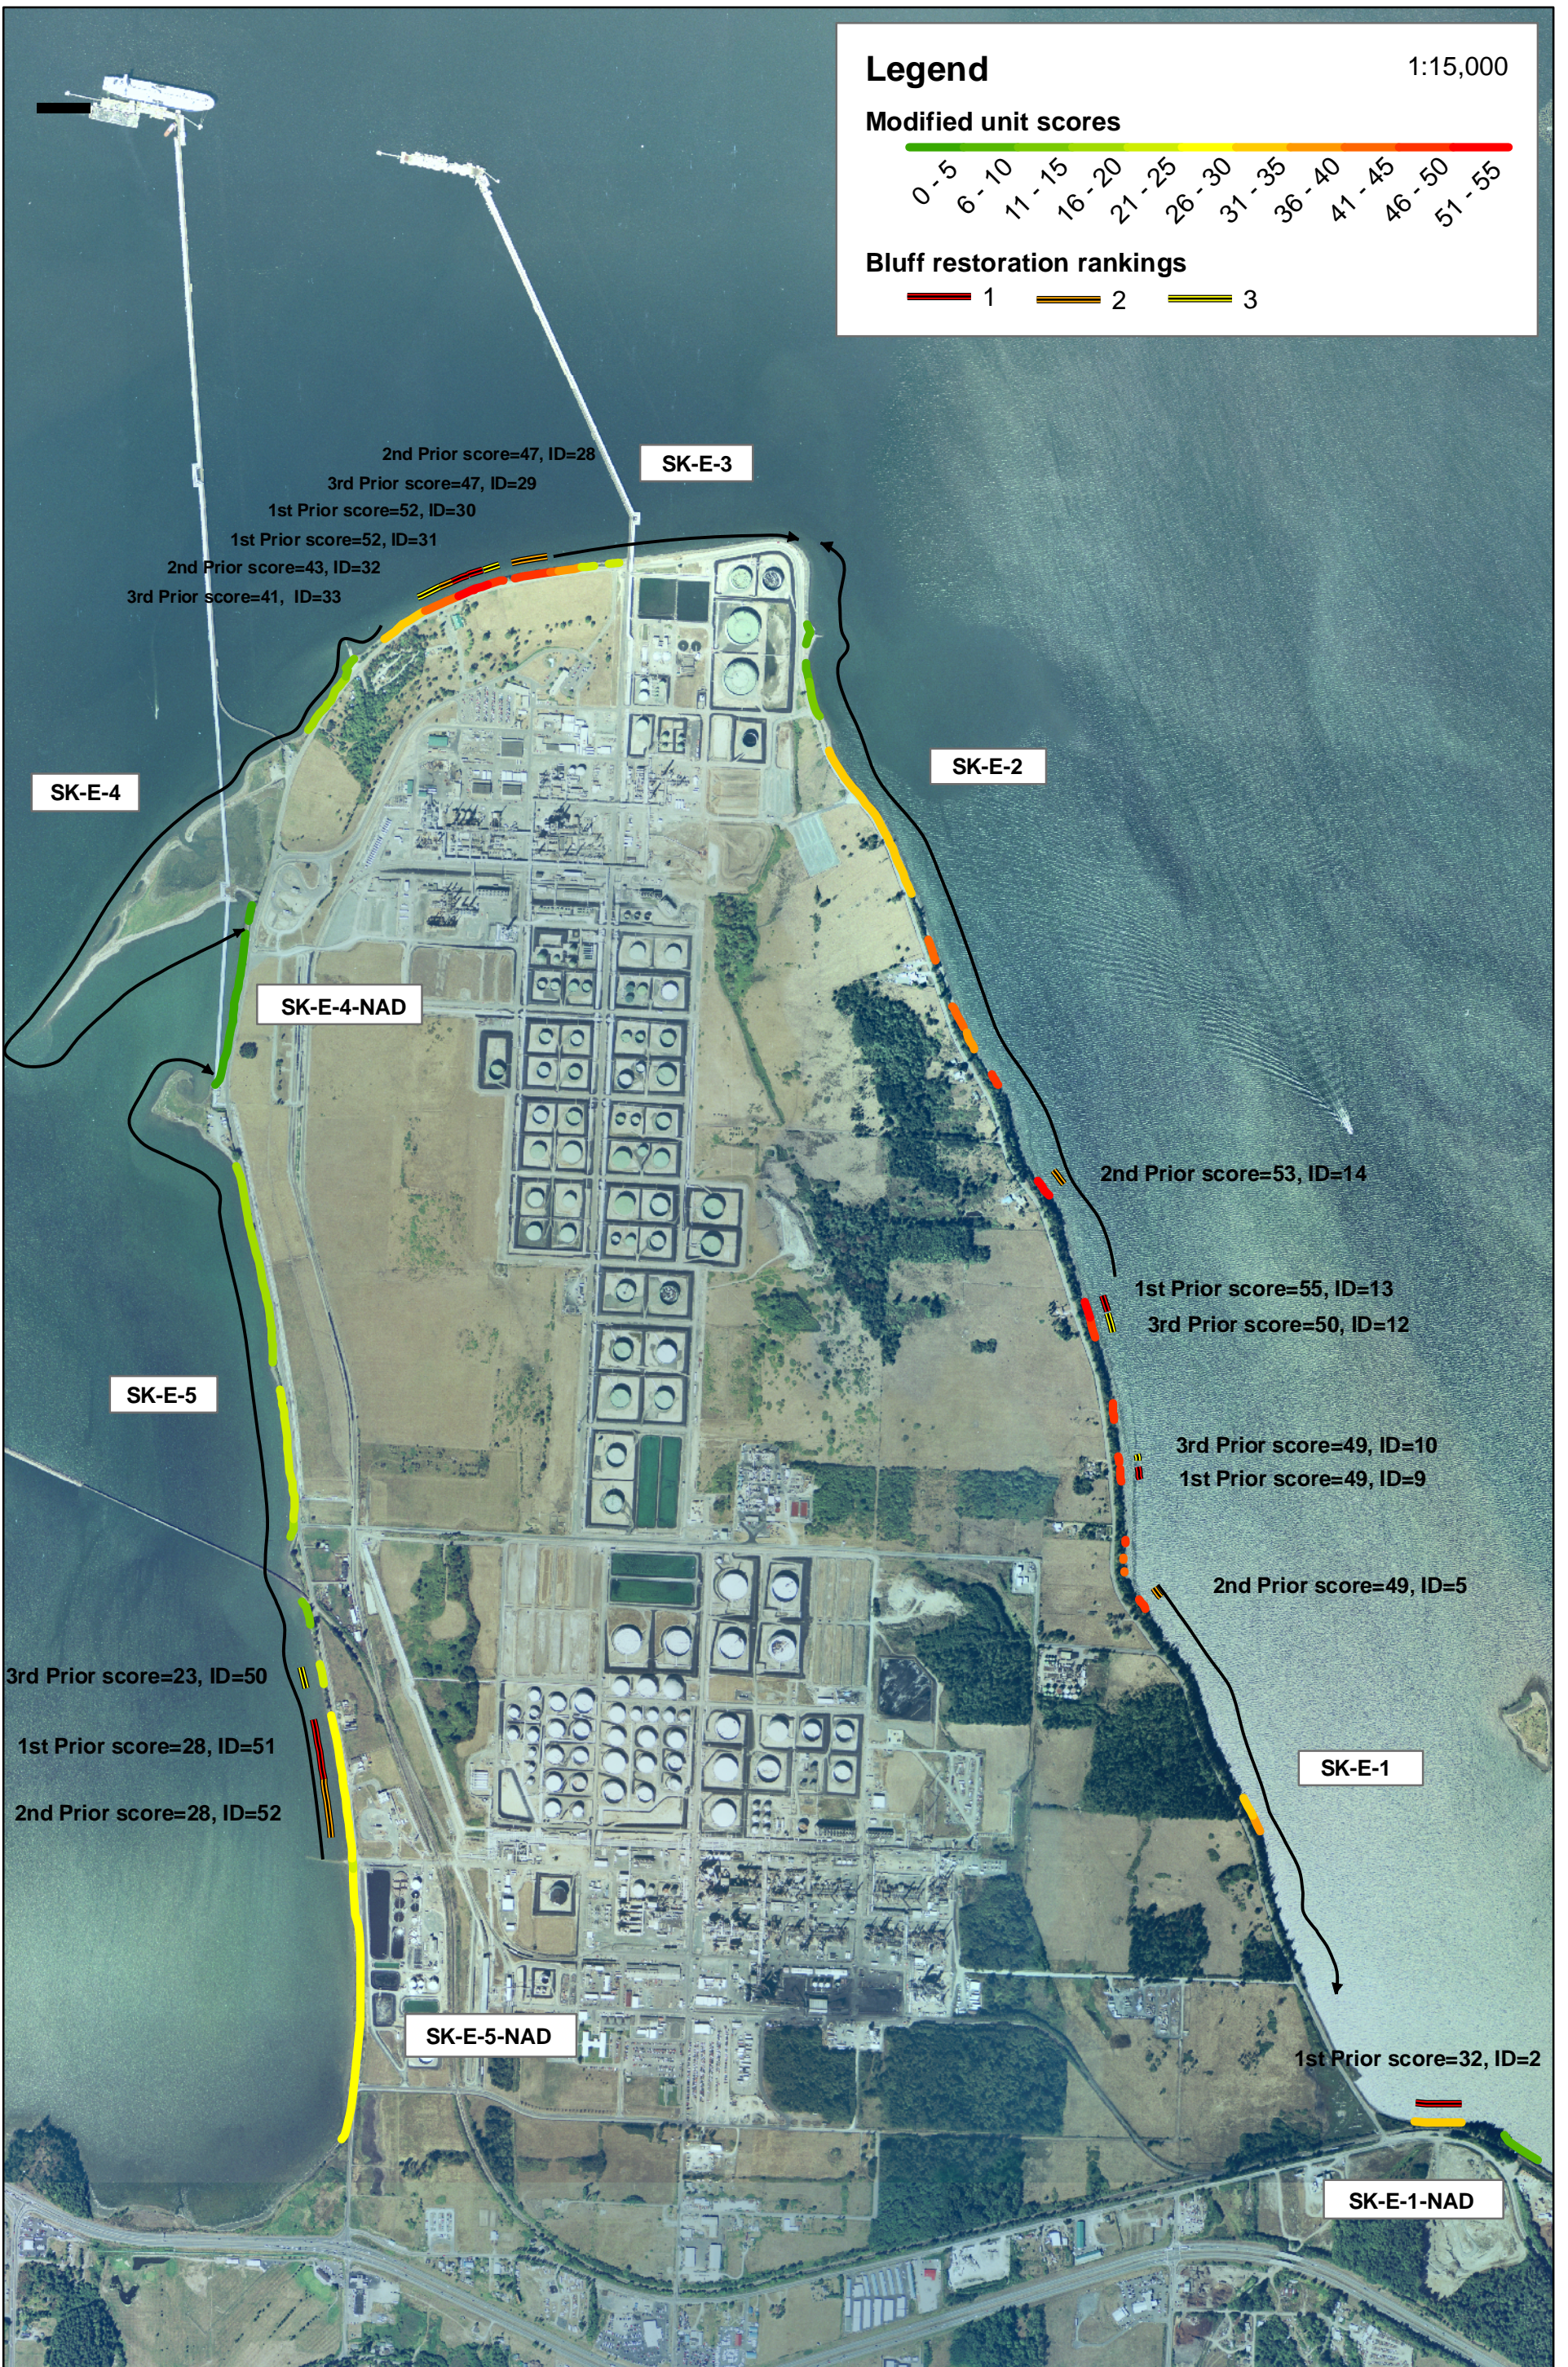
Figure 8. Unit scores for all March's Point modified shores and priority bluff restoration units (buffered offshore)

The highest rated former sediment sources for restoration in drift cells SK-E-2 and SK-E-3, which feed the March's Point Cusp (without consideration for protecting land use), are found in Table 13 and Figure 8.

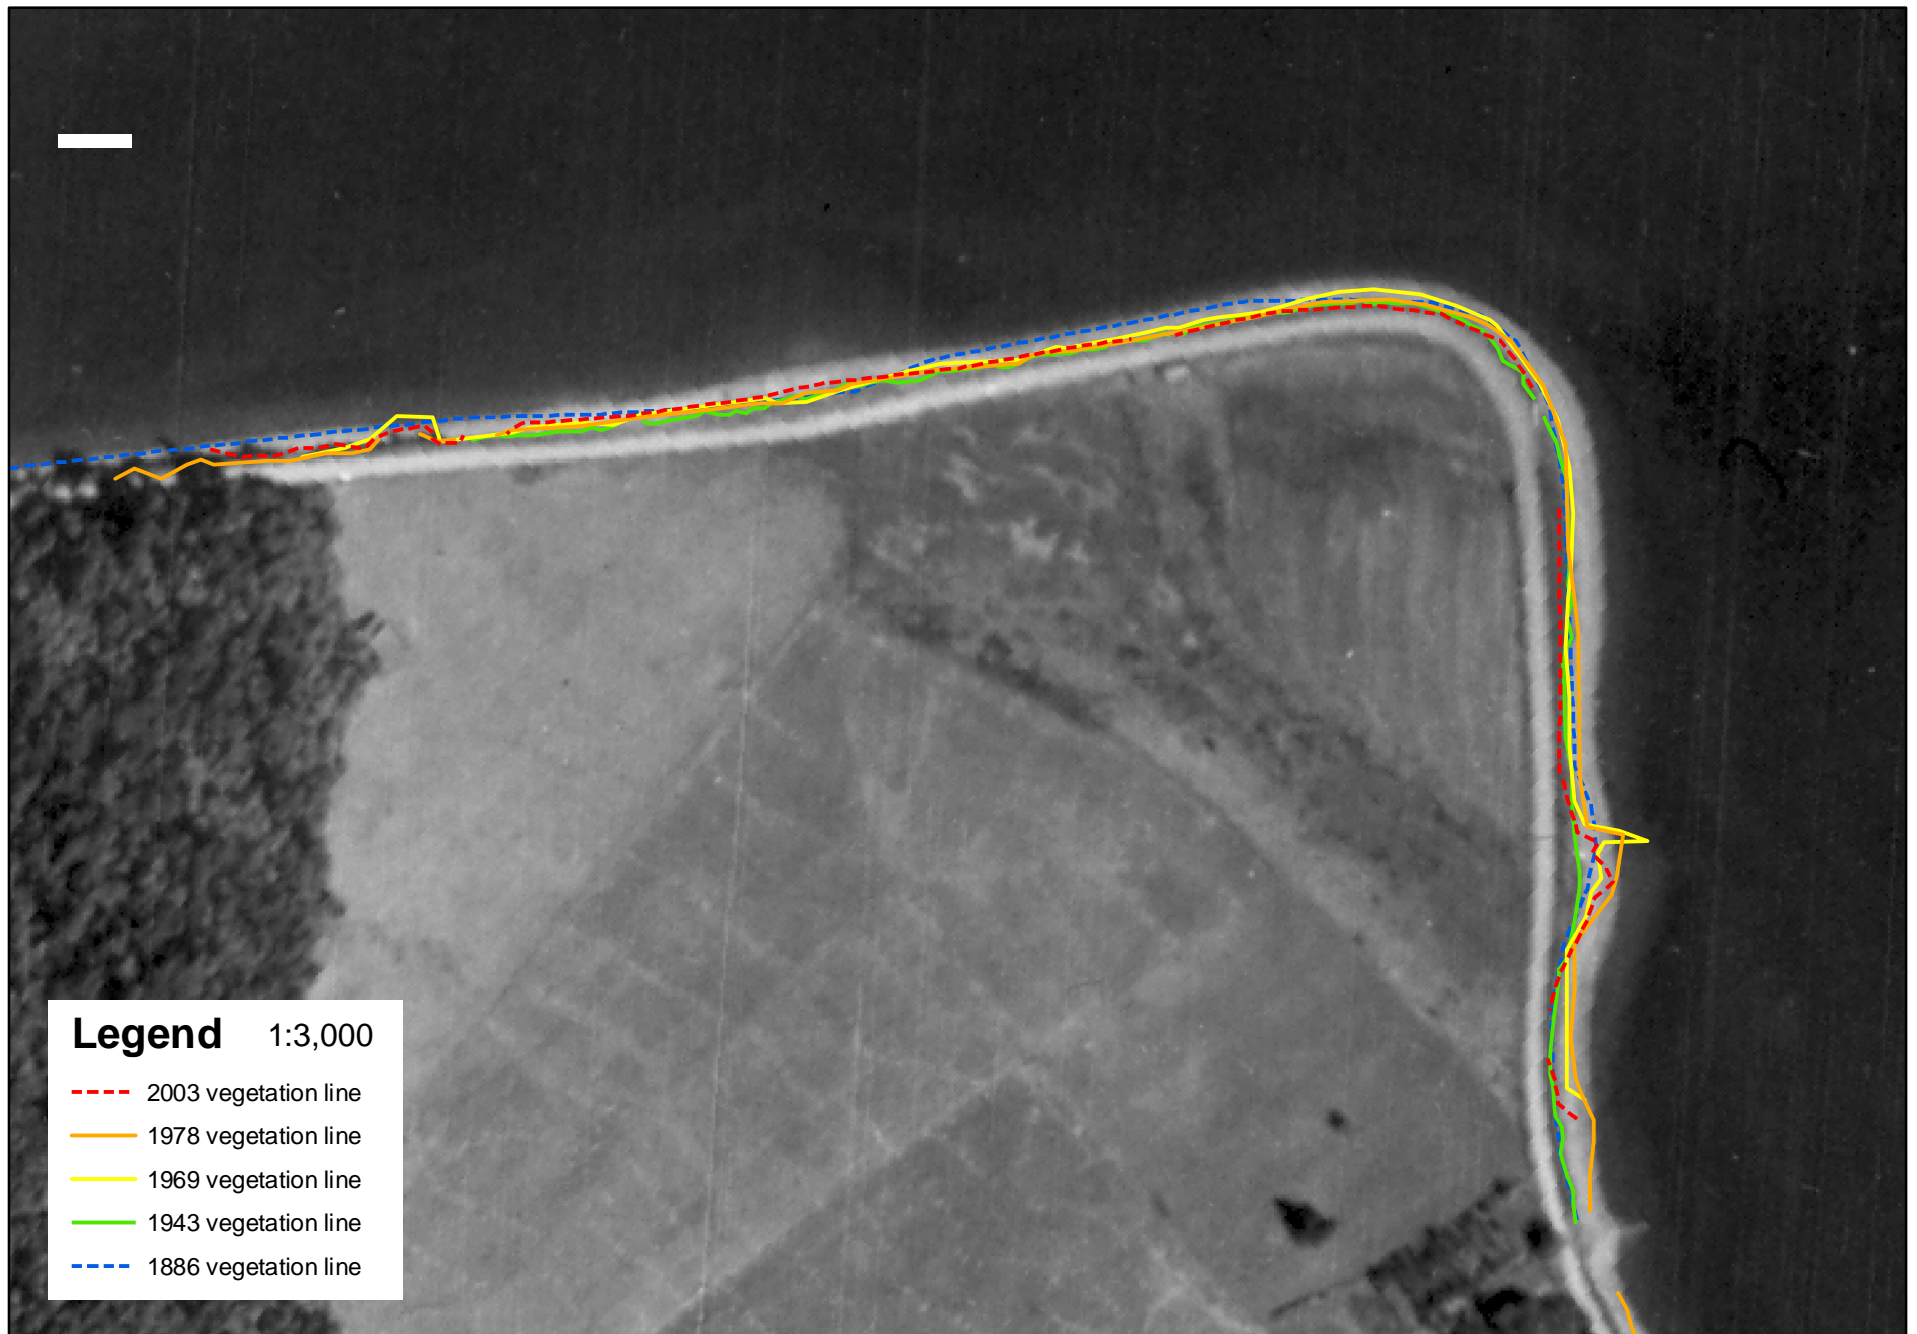
Figure 9. Historic vegetation lines used in shore change analysis of March's Point Cusp.

South of March's Point Cusp - The 2003 vegetation line appears to be closely located to the position of the historic (1886) vegetation line. Accretion appears to have occurred on the south side of the boat launch (found on the northeastern shore of March's Point) between the years of 1886 and 1978. From 1978 erosion appears to have occurred of this accumulation of nearshore sediment, possibly due to waves refracting and focusing wave energy on the southern shore. The general pattern of accretion occurring on the southern side of the boat launch documents the impeded alongshore transport caused by the boat launch groin (also called a jetty).

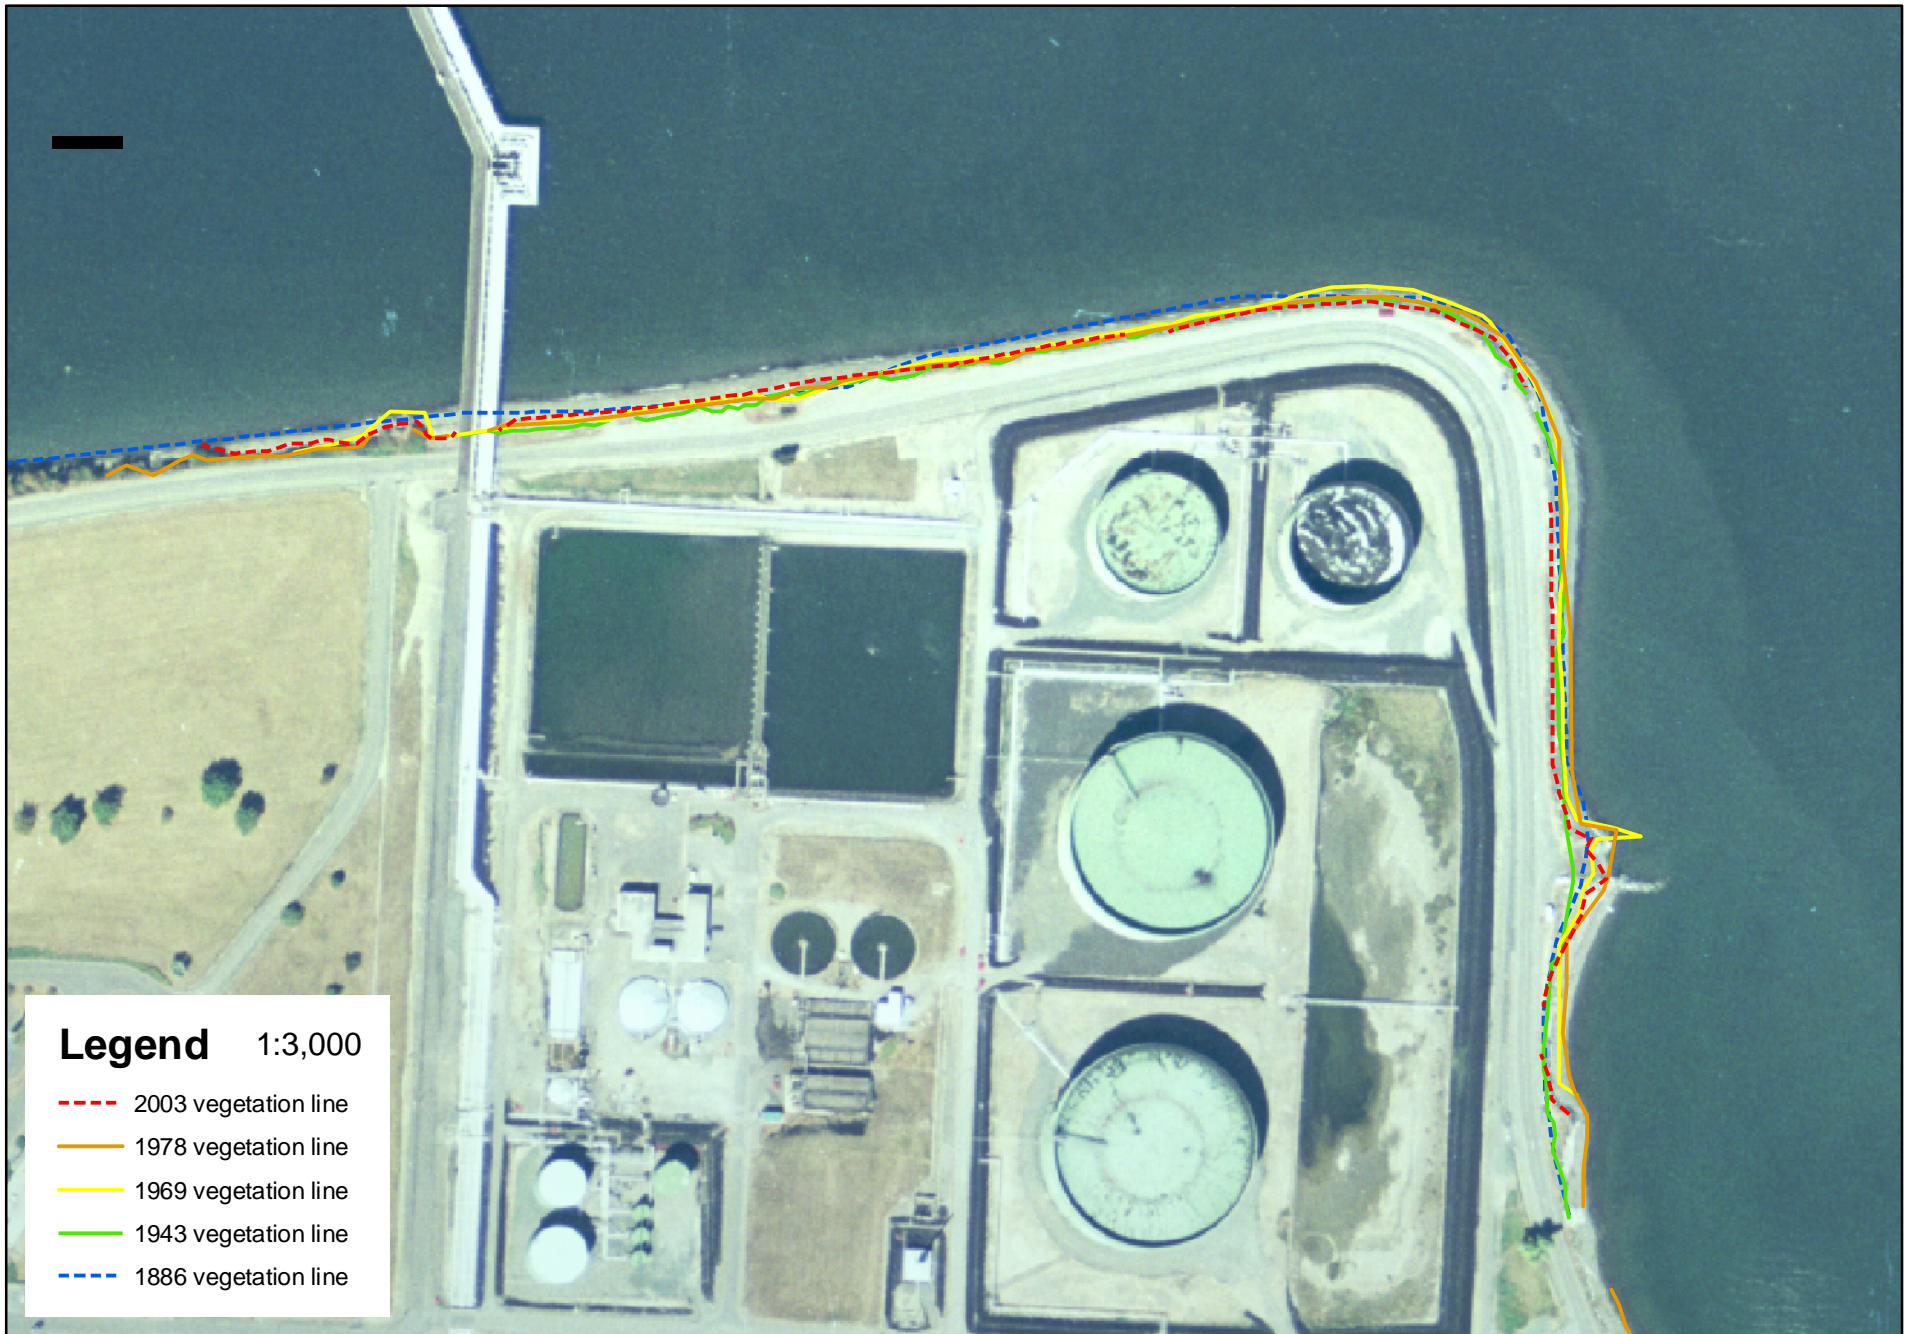
Figure 10. Historic vegetation lines used in shore change analysis of March's Point Cusp.

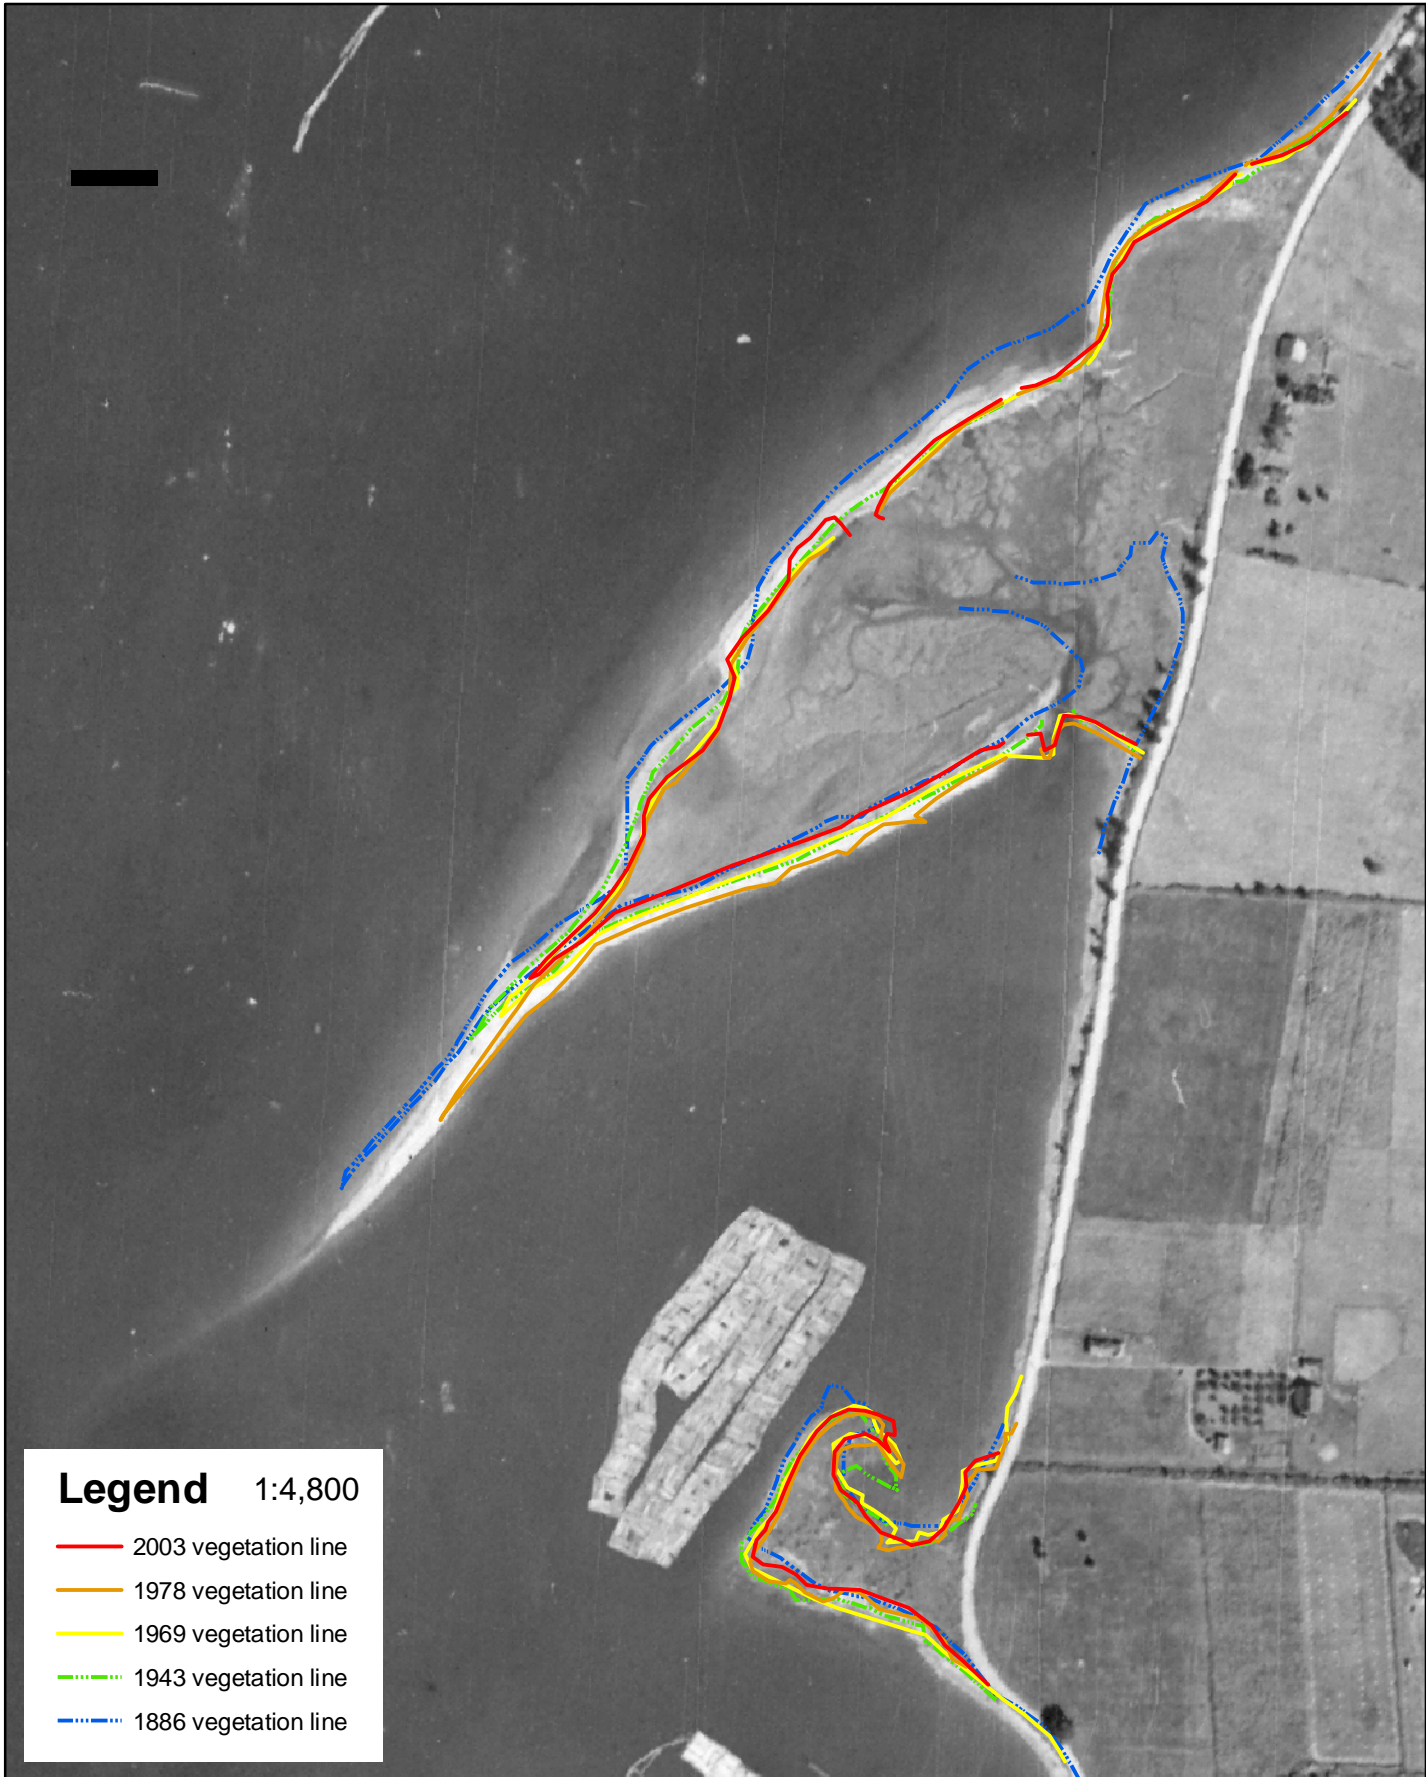
- 2003 vegetation line
- 1978 vegetation line
- 1969 vegetation line
- 1943 vegetation line
- 1886 vegetation line

Figure 11. Historic vegetation lines used in shore change analysis of Crandall Spit shoreforms

The drift cells that supply sediment to the Crandall Spit tidal marsh complex have incurred multiple modifications that have considerably altered coastal processes and the condition of the shoreform. Modifications that have likely contributed to systemic alterations include: a considerable length of revetment and reduction in sediment input, impeded sediment transport, altered tidal hydrodynamics, reduction in wave energy due to wave attenuation from piers, lost bluff and intertidal area from dike and fill areas, and elimination of marine riparian areas. Shore change assessment enables the effects of these changes to become more evident. Photo Page 3 shows 6 views of the Crandall Spit complex and Figures 11 and 12 show air photos and the historic configuration of these shores.

Little Crandall Spit - The recurved spit known as Little Crandall Spit has also changed over the past 110 years (Figures 11 and 12). During the period from 1886-1943, minor accretion occurred along the south shore of Little Crandall Spit, while erosion occurred at the west shore. Minimal shore change was noted between 1943 and 1969, excluding some shore recession of the southwest point and along the leeward side of the recurved spit. Between 1969-1978, a moderate amount of erosion occurred along the south and west shores, as well as along the (northeast) leeward side of the salt marsh. This may have been due to the large change event that occurred during that period (1962), referred to as the Columbus Day Storm. However, it is more likely due to the considerable number of log rafts (as evidenced in the 1943 and 1969 air photos) stored in the vicinity, that likely got loose at times. It is possible that escaped log rafts and single logs, along with associated boat use and wakes could have contributed to the erosion and apparent marsh surface degradation that occurred during this period. A large barge became stranded on the south shore of the spit by 1969 (the eastern barge) and several other pieces of large barge and log raft debris were present starting in the 1970s.

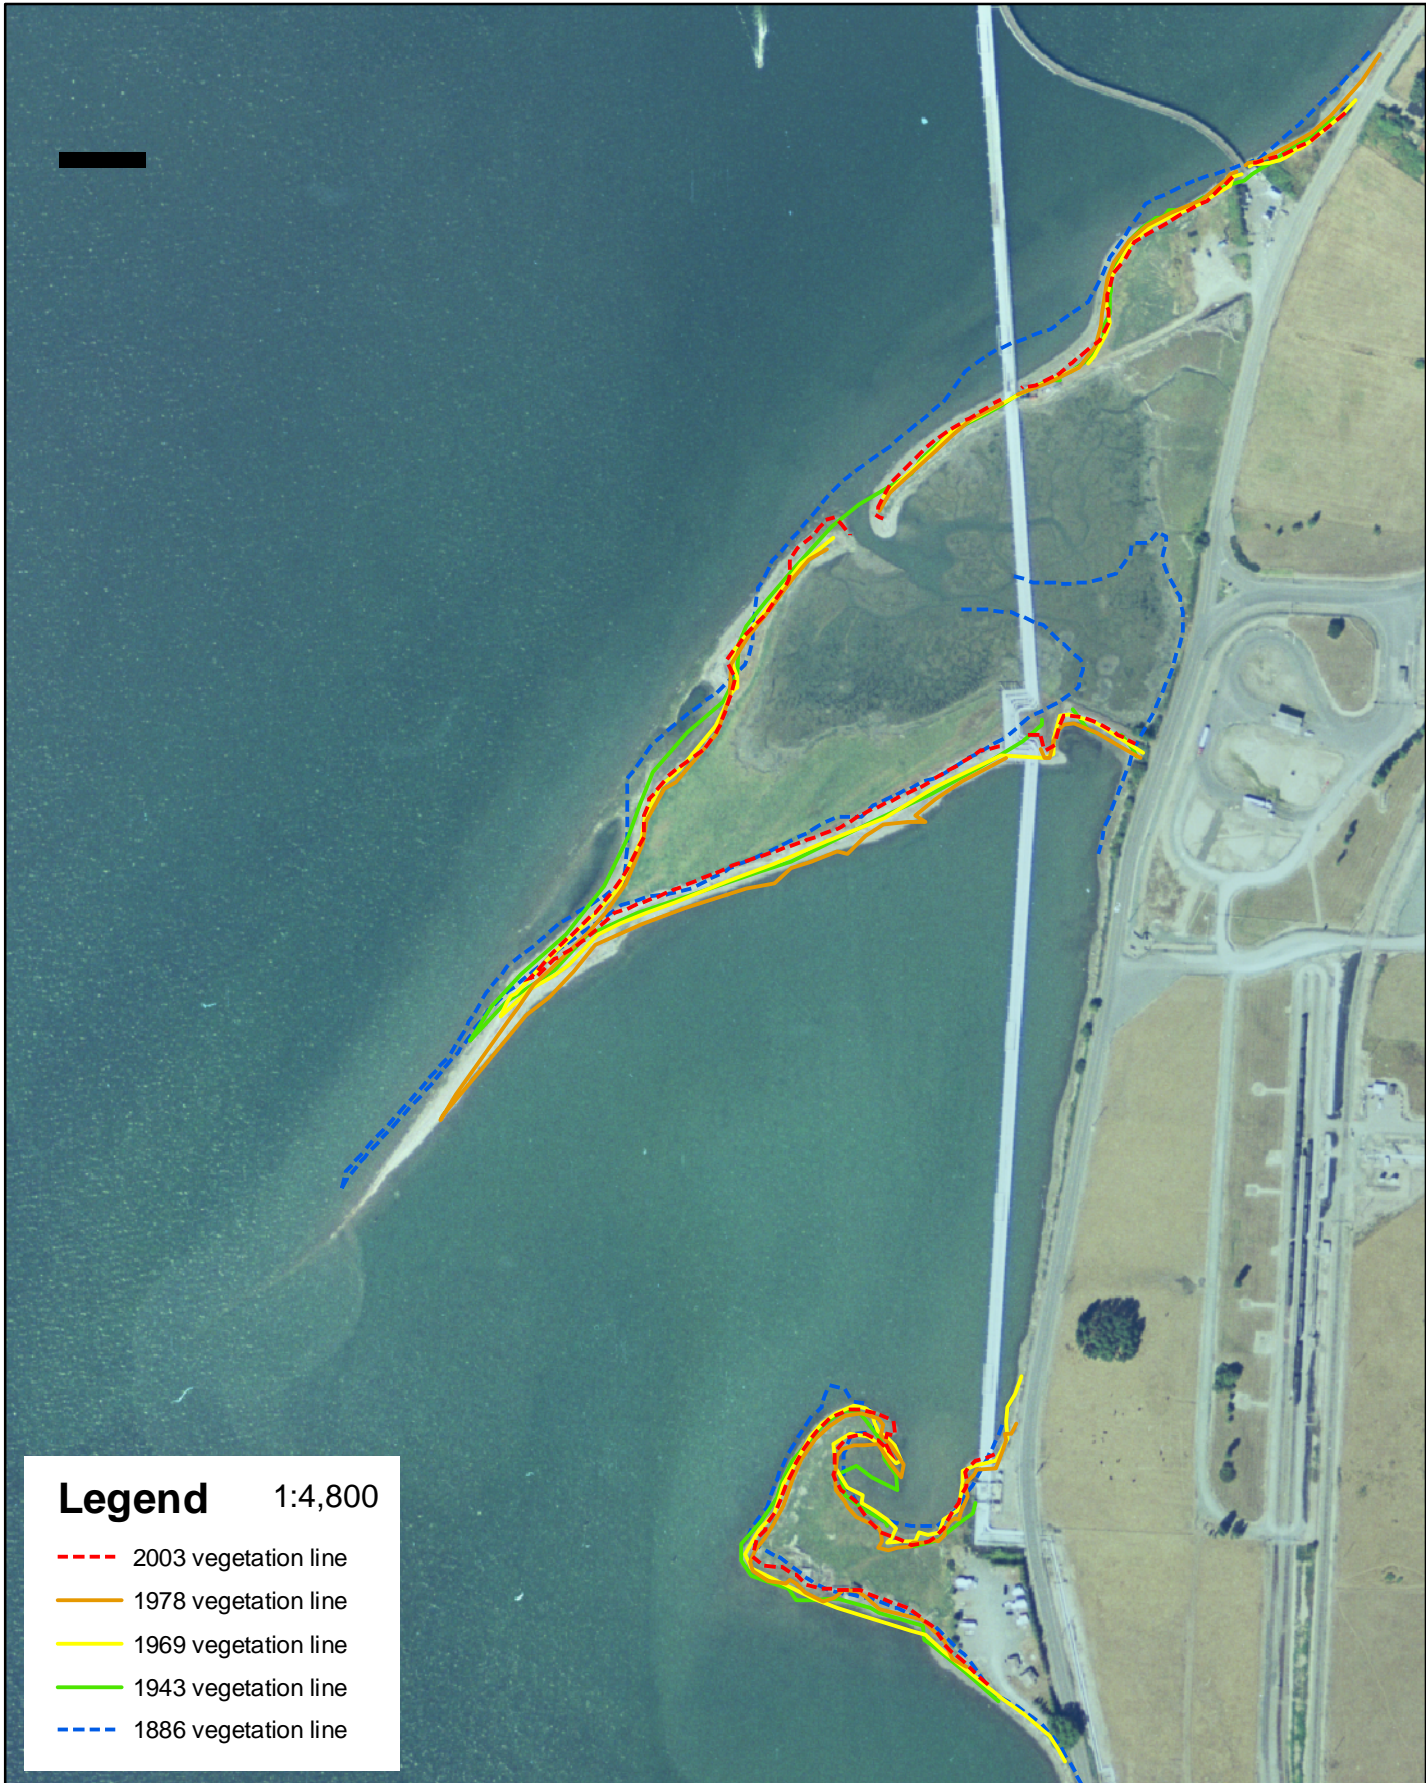
Figure 12. Historic vegetation lines used in shore change analysis of Crandall Spit shoreforms

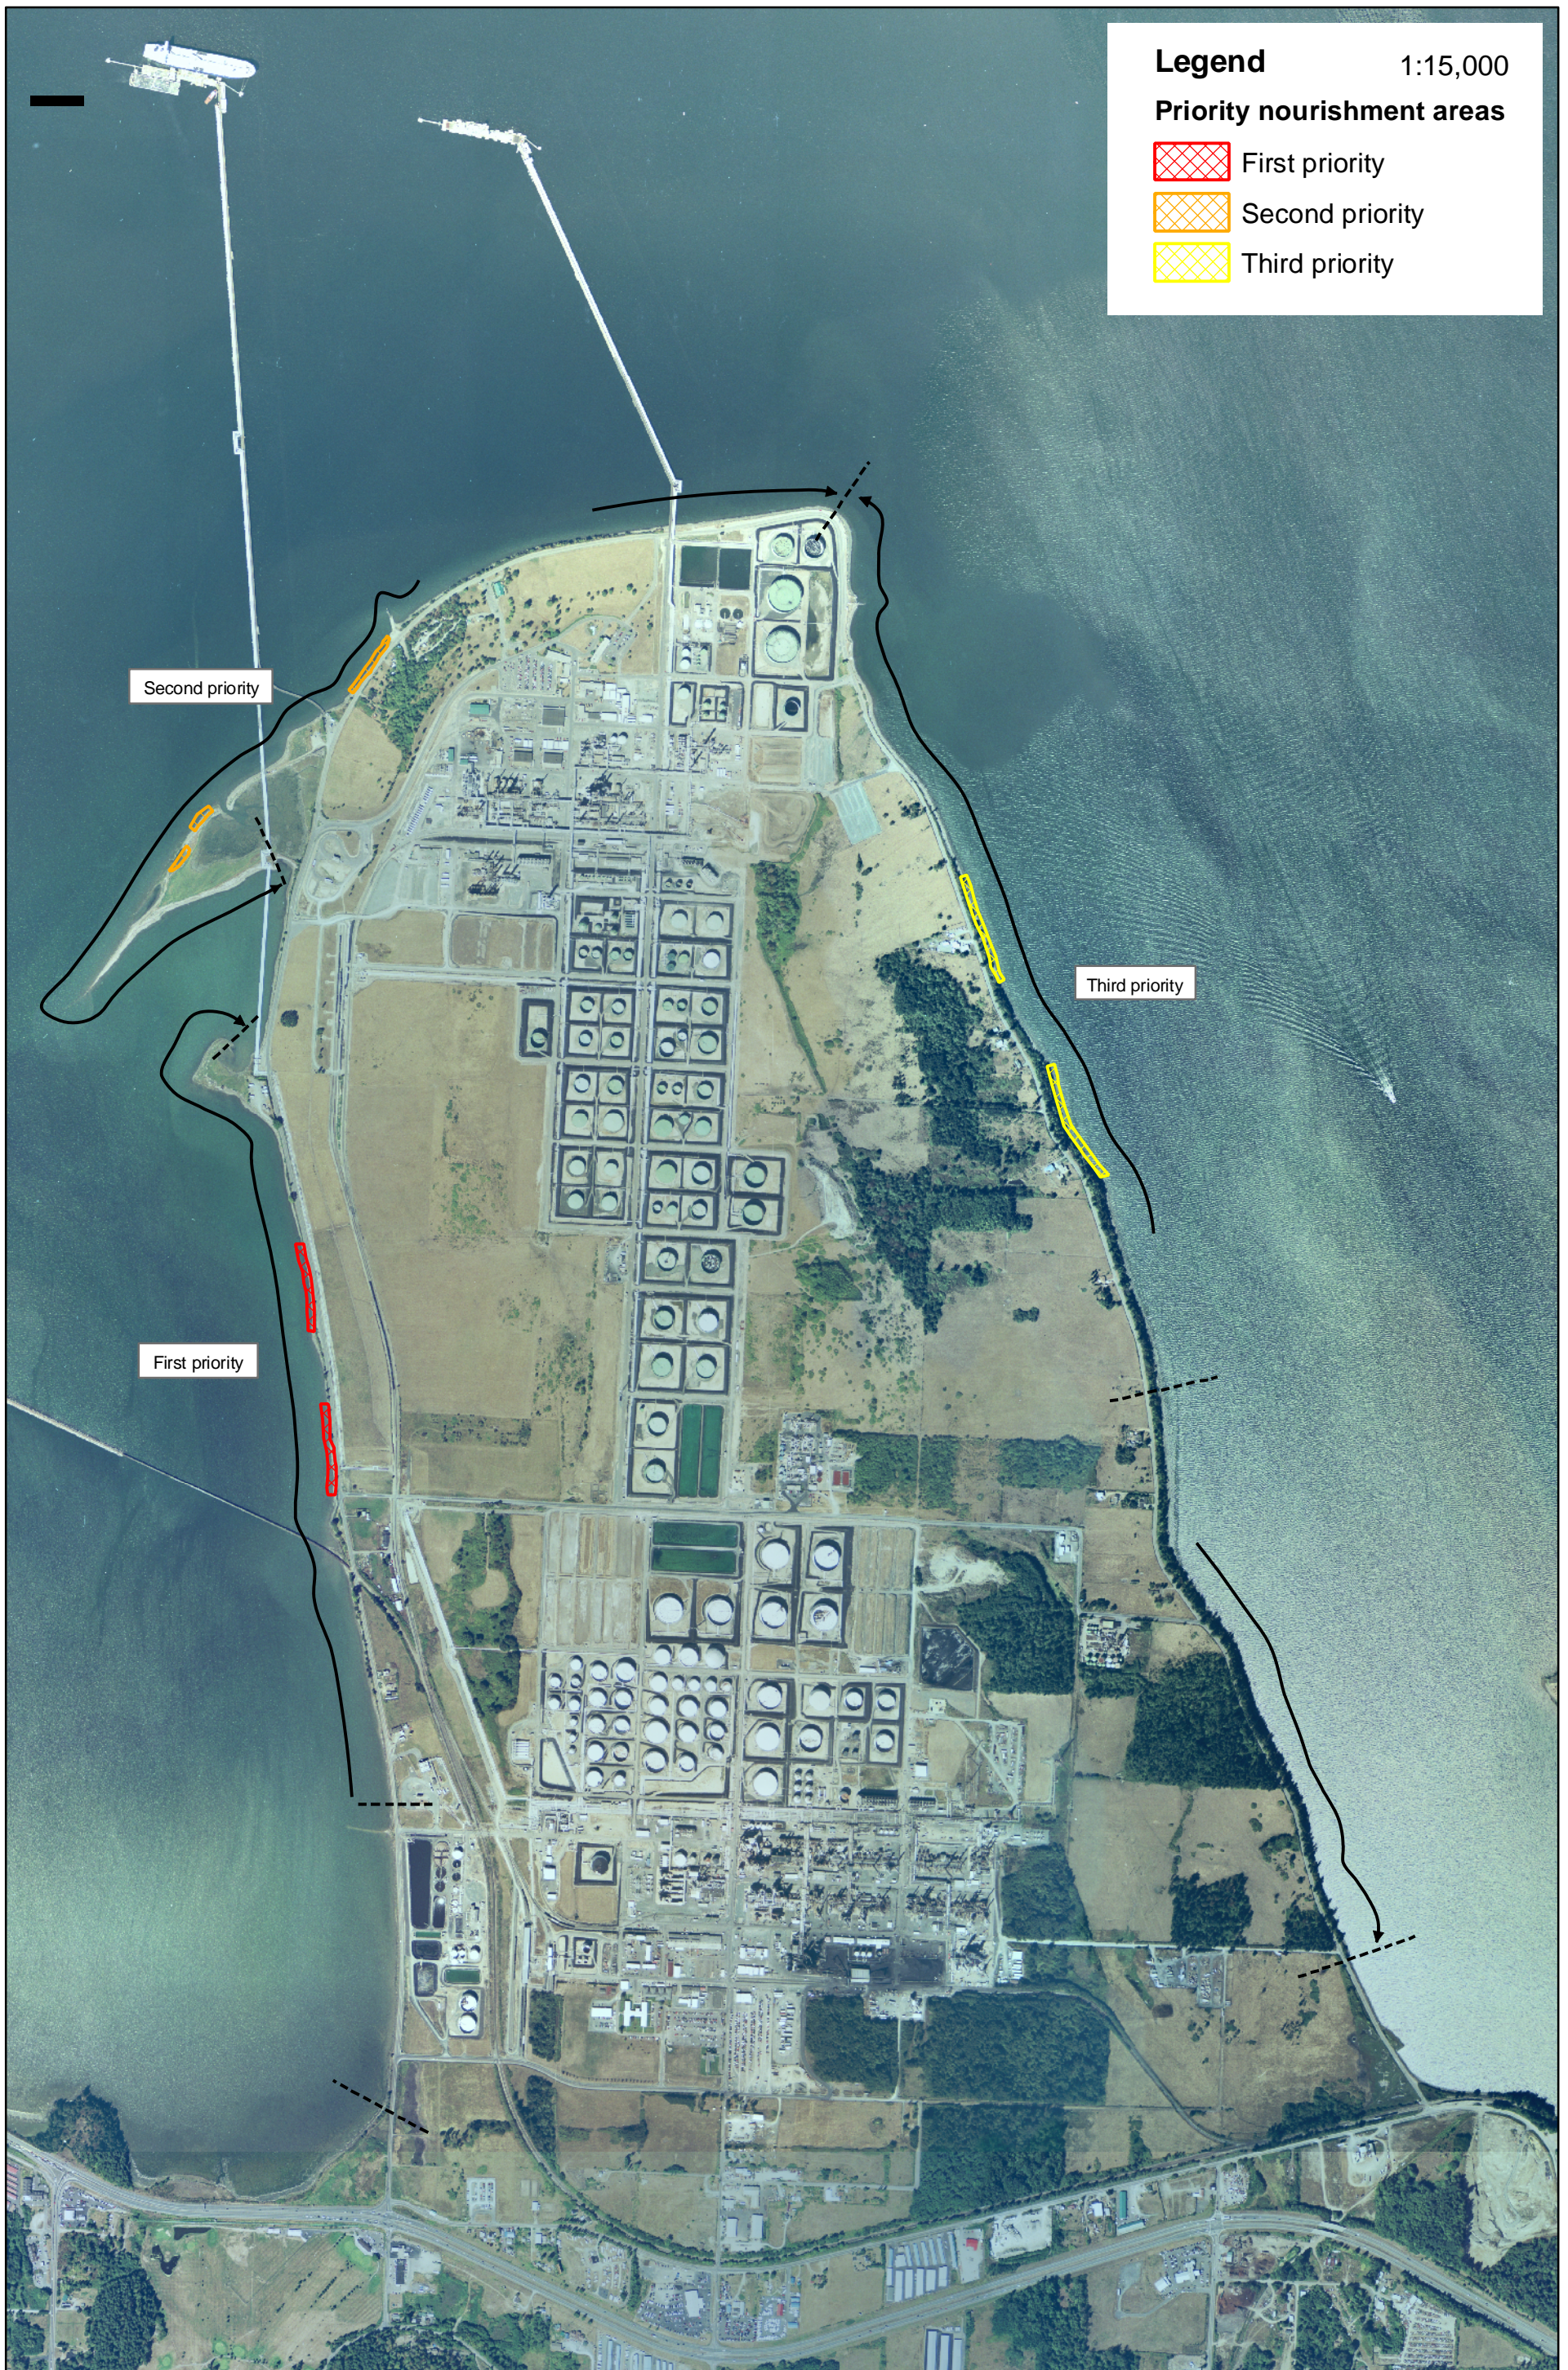
Figure 18. Priority beach nourishment areas of March's Point.
