DELIVERABLES FOR TASK NO: 3.10 (Boulevard Park intertidal survey final report)

Intertidal Biota Monitoring at Boulevard Park, Bellingham, WA

Monitoring Report

September 2019

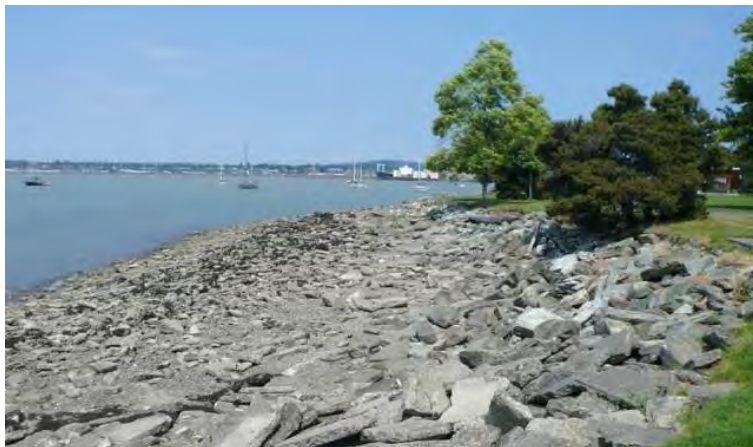
Figure 2: Boulevard Park before shoreline enhancement. (Photo by City of Bellingham.)

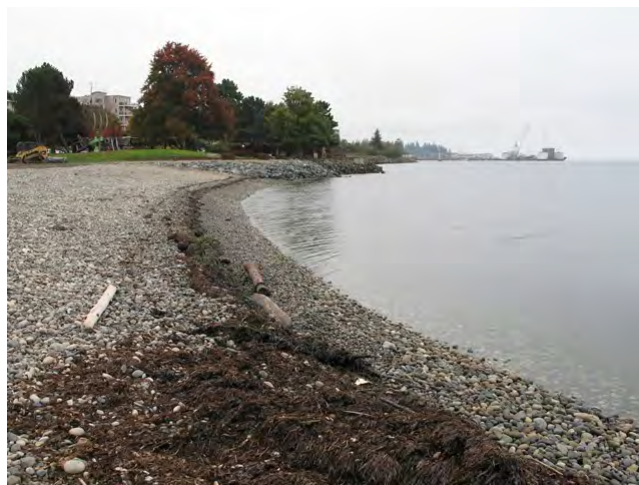
Figure 3: Boulevard Park after shoreline enhancement. (Photo by City of Bellingham.)

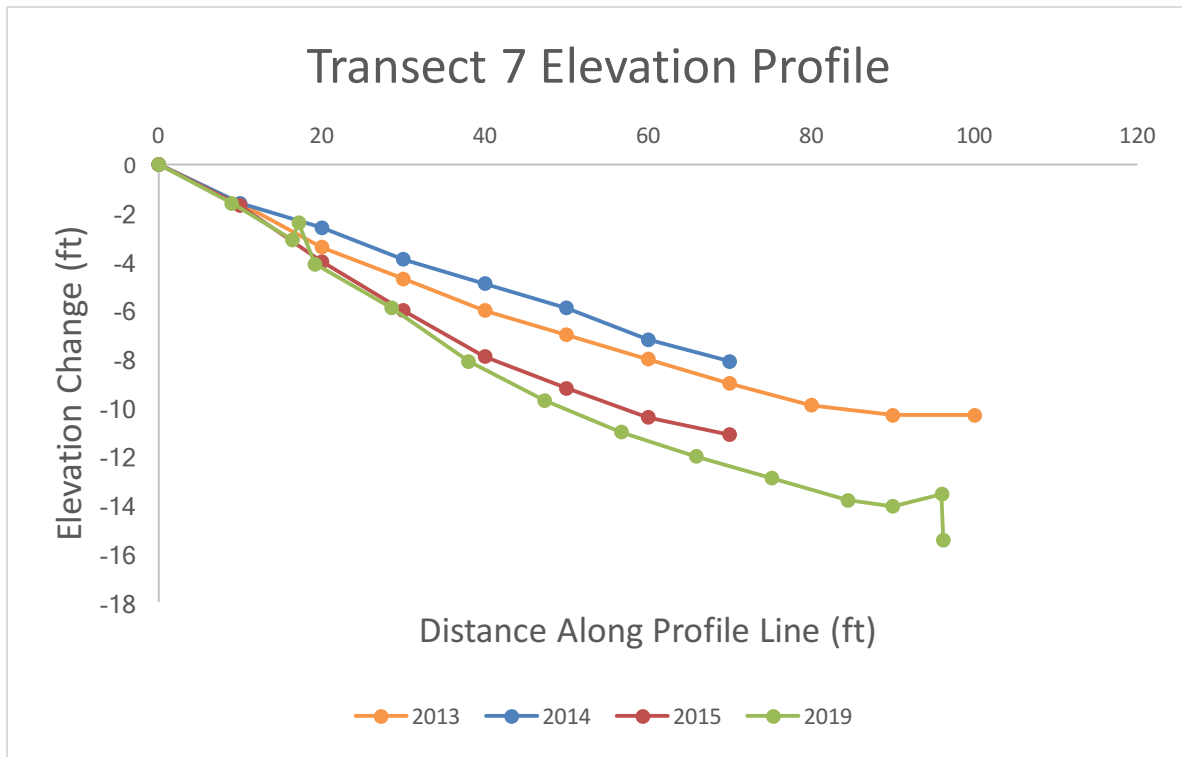
Figure 22: Transect 7 2019 slope corrected if start point was corrected to start at the top of the riprap, rather than below. Slope of Transect 7 from Ordinary High Water to the water’s edge, in years 2013, 2014, 2015 and 2019.

The substrate in Transect 7 can generally be characterized as mainly gravel and cobble, with boulders past 90 ft on the profile line, as seen as the bump in 2019 (Figures 21 and 22), in contrast to the 2013 slope which was pre-enhancement. The bump between 10 and 20 ft on the profile line in 2019 marks where there was a log on the beach. Transect 7 appears to be have a steeper slope in 2019, indicating that the beach may have experienced scouring, which is consistent with the 2014 to 2015 slope steepening seen after the enhancement project happened. Figure 21 shows the measured elevation profile for 2019, which started at the bottom of a riprap drop off while Figure 22 shows a correction for possibly not starting at the same starting point in 2019 previously used in 2013 through 2015.
